## **CHAPTER - 1**

### **INTRODUCTION**

#### **1.1 Background to the Proposed Project**

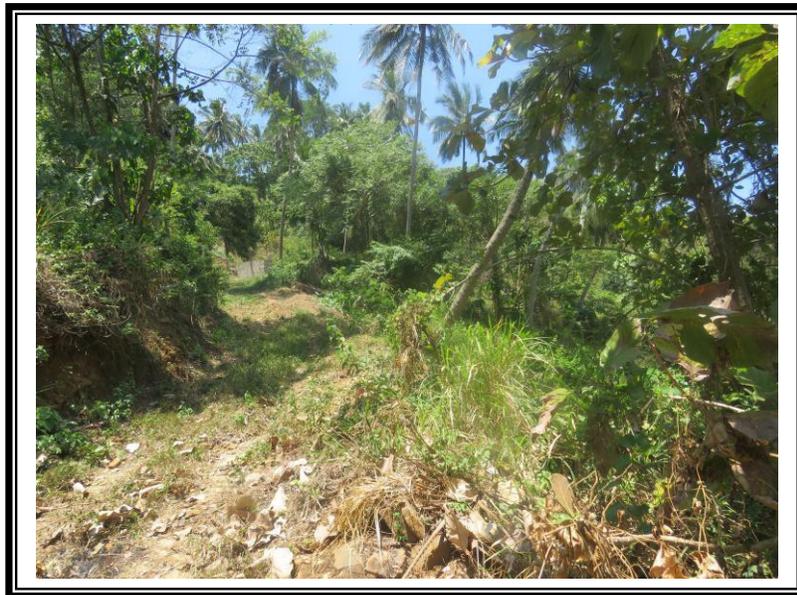
**Plate – 2.2.2:** Presence of man modified habitats such as home gardens, coconut plantations and secondary vegetation within the project area

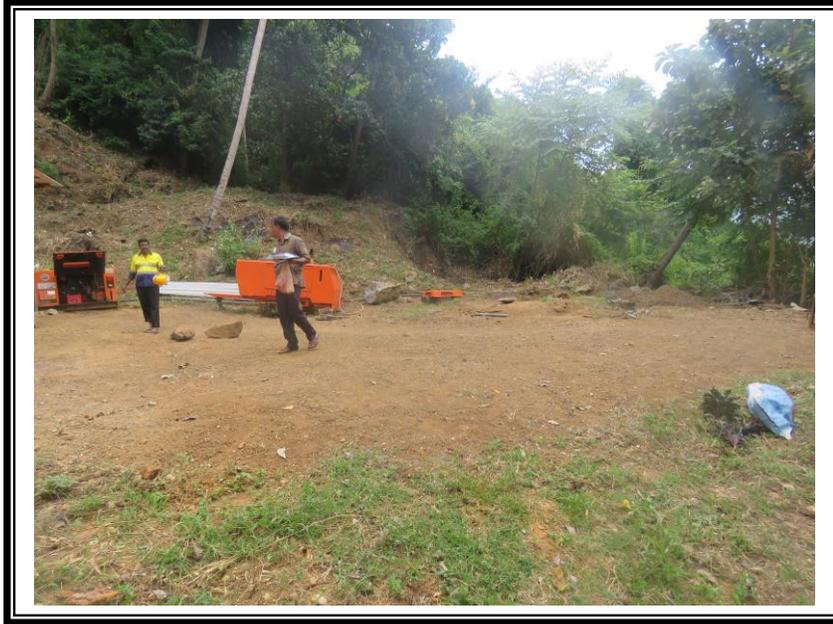
**Plate – 2.3.1:** Horizontal ground area prepared in front of the mine entrance to stockpile mined out graphite fragments and graphite bearing rocks until they are separated by manual chipping

some rock blasting will have to be carried out. Blasted rocks will be dumped within the area selected for waste rock dumping site. Space available in front of the mine entrance will be used as stockpiling sites (Fig. 2.3.1).

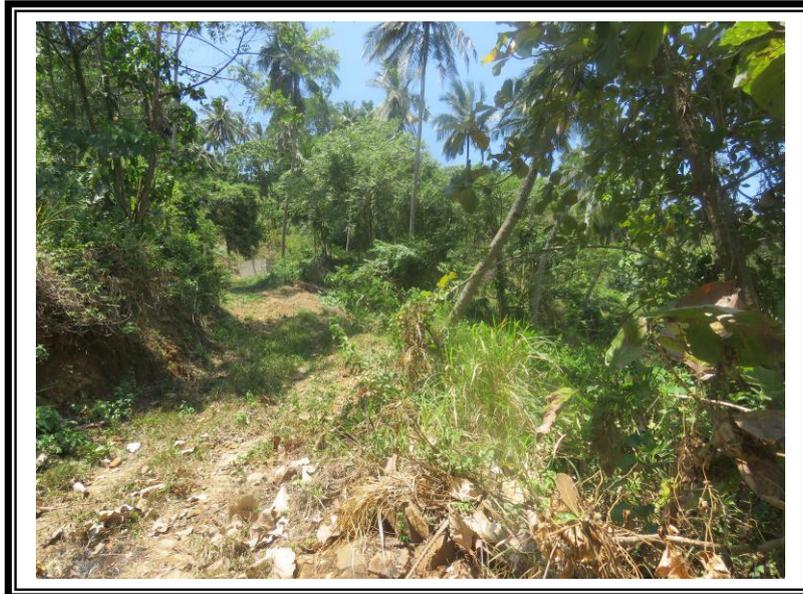
**Plate – 2.3.3:** Poor condition of access road leading to the mine site from the office premises

About 400m long existing access road leading to the mine site from the company office premises will have to be upgraded with developing roadside drainage path. It is recommended to apply a bonding material like Tar on the surface of the access road. Roadside drainage path will be rock paved.

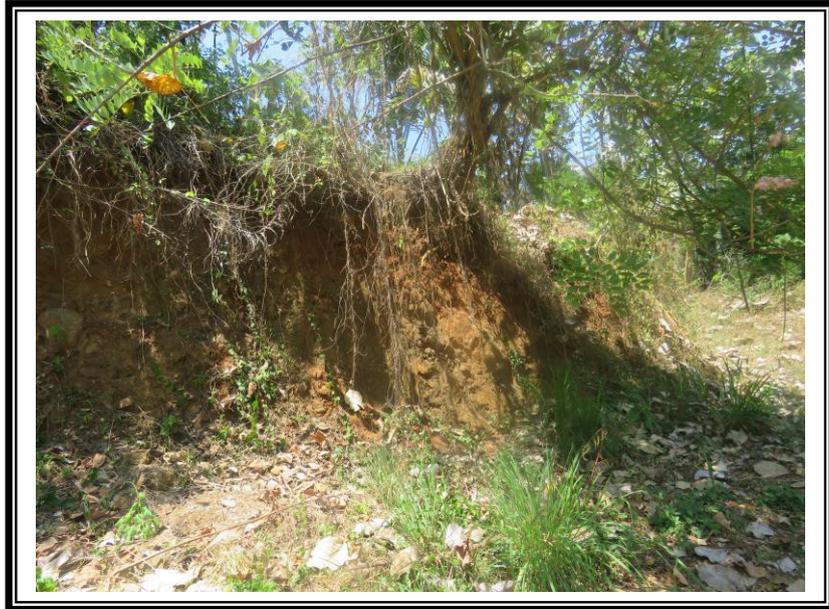
At places of this road, minor collapsing has been identified in roadside slope embankment due to steep cutting (Plate – 2.3.3A). Hence, it is recommended to shape the roadside slope embankment in 1:4 ratio and allow creepers to grow along the slope in order to avoid further collapsing. Otherwise, it is recommended to identify such places and erect rock paved retaining walls.

**Plate – 2.3.3:** Minor collapsing of roadside slope embankment at places along the access road

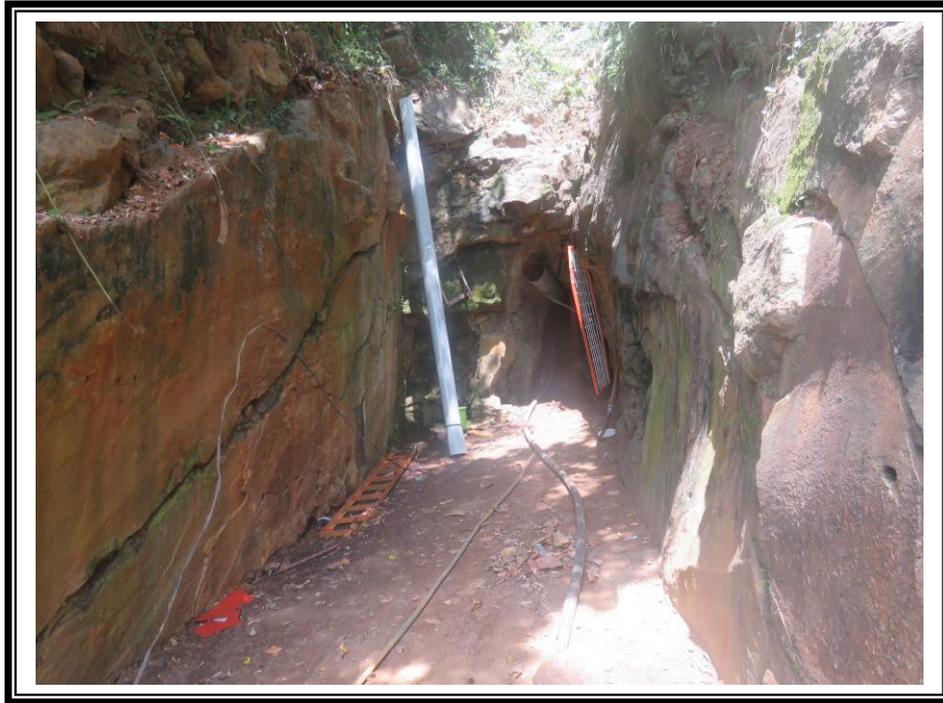
Cleaning of the abandoned mine complex has identified that the proposed mine comprises of abandoned 2 shafts and 3 adit structures (Plates – 2.4.1.1 & 2.4.1.1A). During the clearing process of the mine structure, new drives were found and observed remaining graphite veins in their walls (Plate – 2.4.1.1B).

**Plate – 2.4.1.1: Mine Entrance**

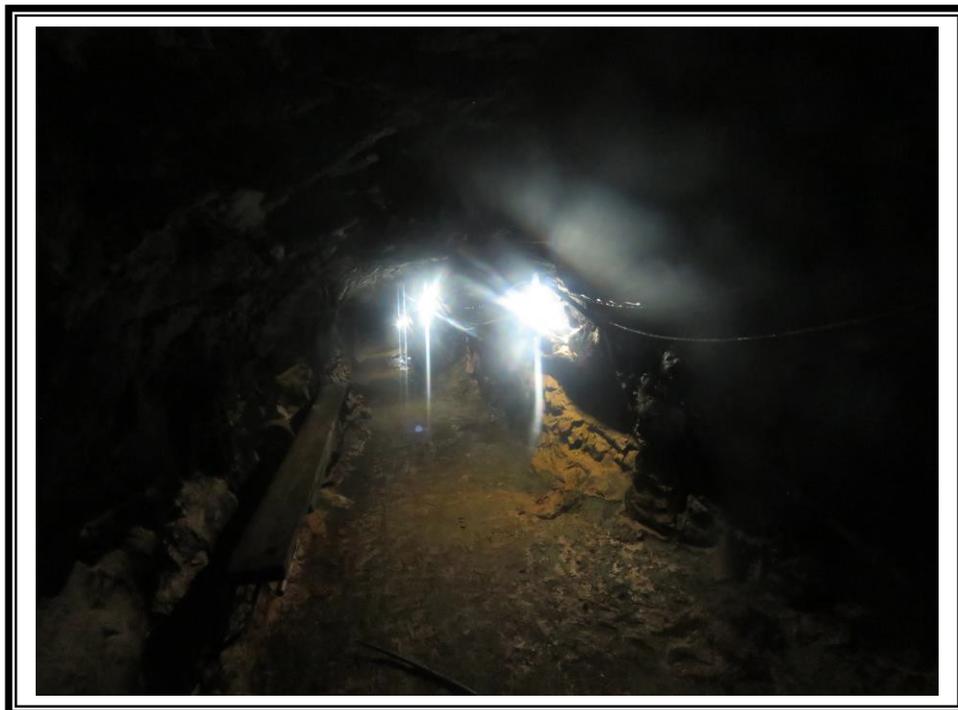
**Plate – 2.4.1.1A: Cleaned Adit Structure**

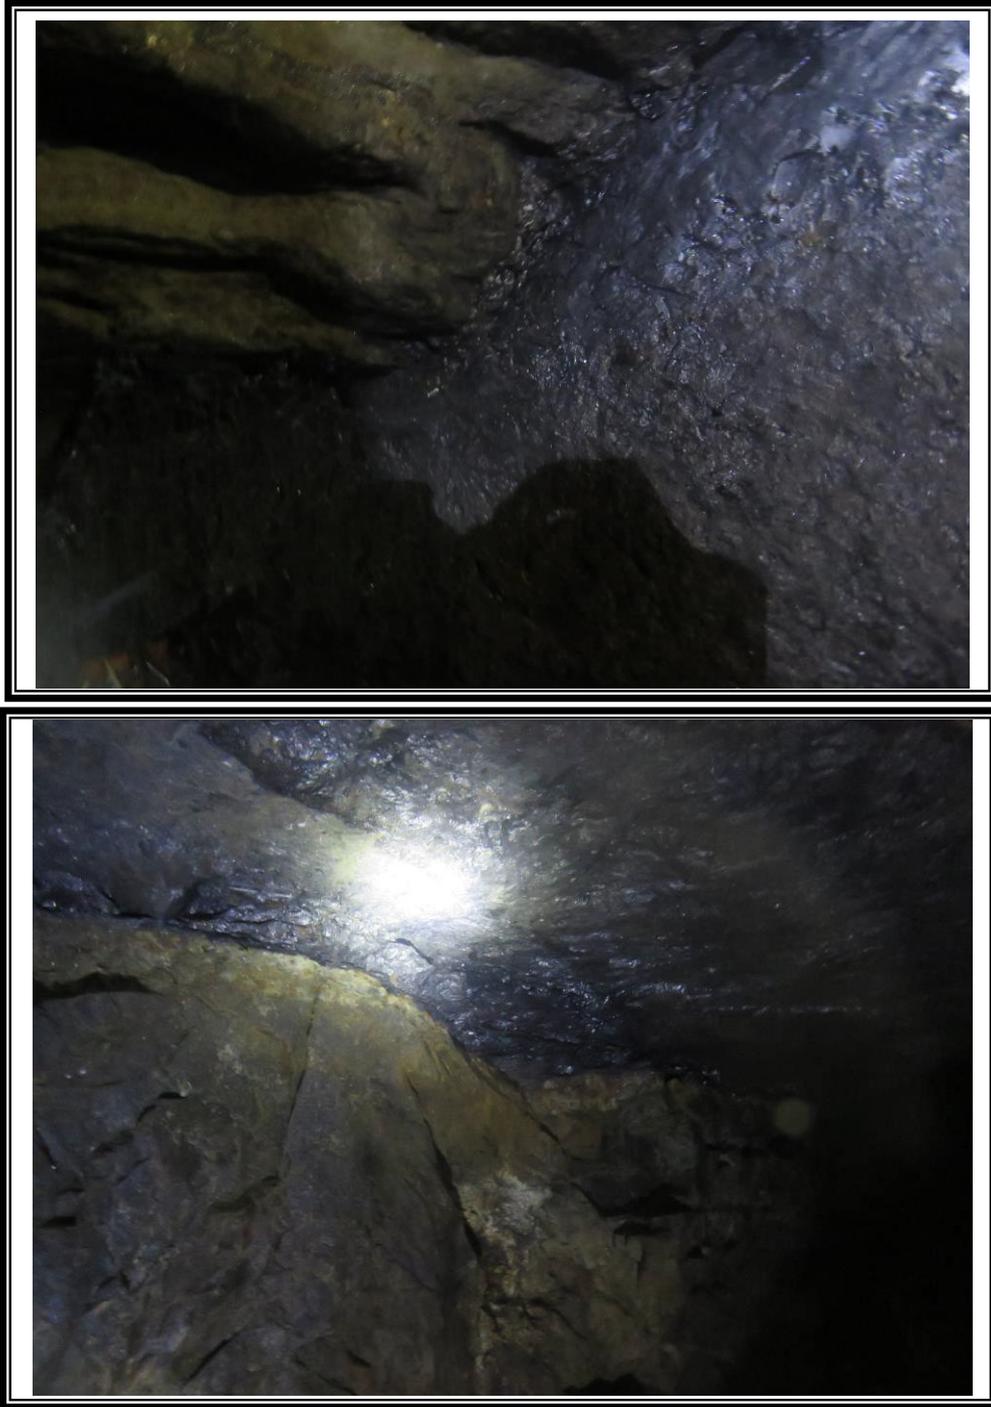
**Plate – 2.4.1.1B:** Presence of a Graphite Veins in the mine

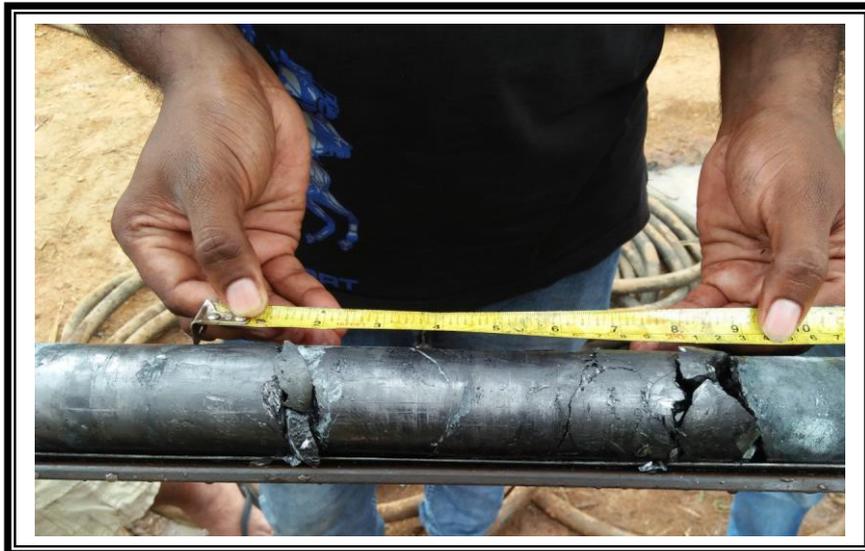
**Plate – 2.4.1.2:** About 30 cm graphite vein intersected by one of the drill holes

A detailed examination of available drill cores has indicated that all the holes have traversed through number of graphite veins / veinlets (with each vein / veinlet having varying thickness of 6 – 30cm) (Plate – 2.4.1.2).

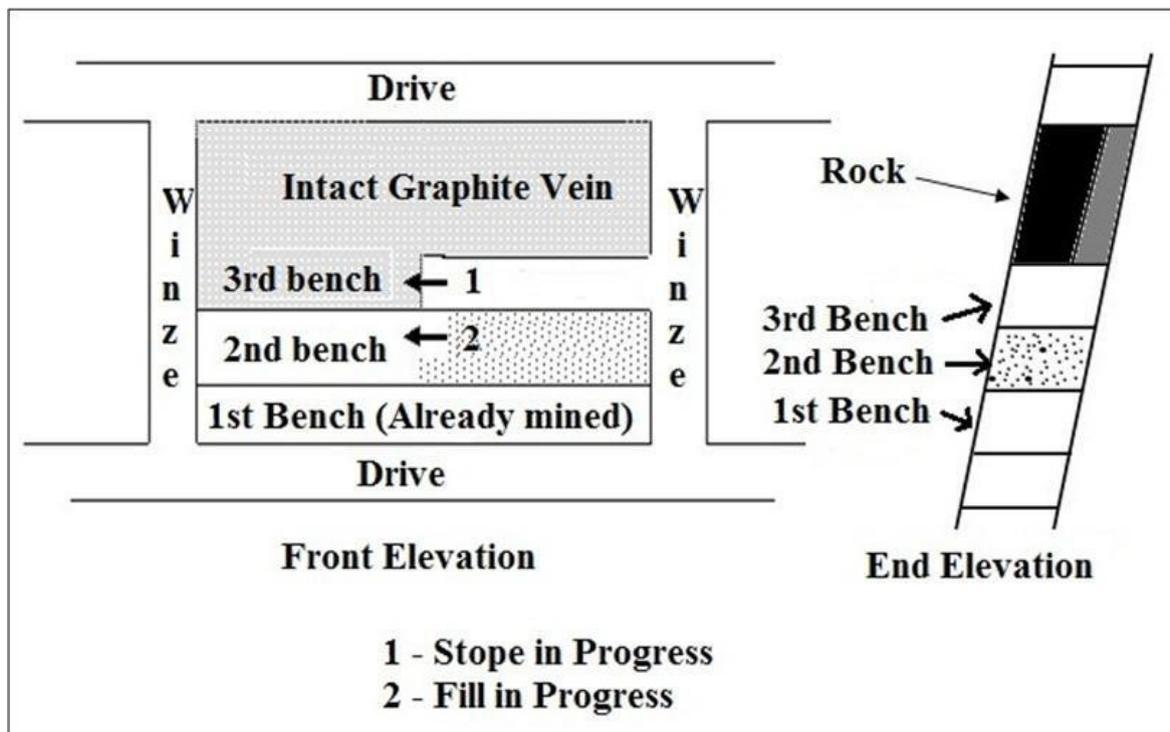
Under the given geo-mechanical conditions, the proposed mining method for the steep-dipping graphite veins within weak hanging and footwalls will be **Cut-and-Fill method** (Refer Figure 2.4.1.5). The block of graphite with upper and lower drifts serving as horizontal boundaries and two winzes located 30-40 m apart serving as the vertical boundaries makes one unit of production. Extraction of the block starts with the initial horizontal slice starting from the lower drift and working upwards. In this manner the slices progress upwards to the upper drive in a zig-zag pattern. The lower bench or slice is filled while the upper slice is taken. Adequate roof support of the bench is essential in this extraction work. Roof support timber or second-hand rail cap is recommended. For hanging and foot wall supports, use of rock bolting is recommended.

Figure - 2.4.1.5: Cut-and-Fill mining method

There will be no subsidence since all the tunnels and drifts are supported and stoped out area is filled with broken rocks from development work and excavated winzes. Cut and mining method means, extracted area is filled with broken rocks.

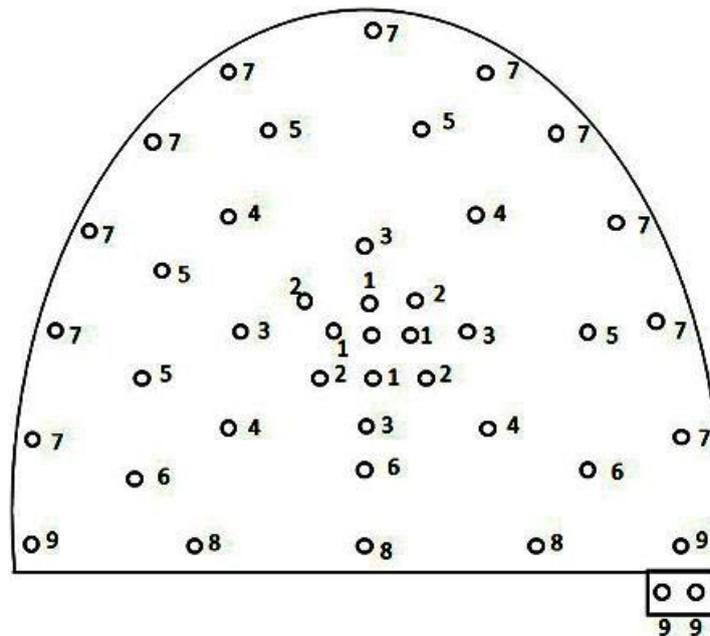
Cross-section recommended is 2.2 x 2.1 m<sup>2</sup>. Drilling configuration and the charging pattern are shown in Figure 2.5 below.

**Figure - 2.4.1.12:** Tunnel section showing the drilling pattern and the blasting sequence

Type of Rock	Garnetiferous quartzofeldspathic gneiss (Ref. RS Mines Exploration Report)
Tunnel Cross section	2.2 X 2.1 m <sup>2</sup> (before lining)
Cut-hole round	Burn-cut
Max. drilling depth	1.5 m
Drill hole diameter	32 mm
Blasting sequence – Cut-holes	Half-second
Blasting – reliefs, roof holes, trimmers, and the bottom holes	Milli-second
Explosives - Primer	Water-gel / Emulsion- 22/28 X 200 mm
Explosive- Rest of the holes	ANFO in cartridge form
Method of initiation	Electric initiation

Drilling and the blast pattern of the drift is shown in Figure 2.4.1.12(a) below. Exposed graphite vein is subjected to cautious blasting to ensure minimum formation of dust that will lead to losses. Blasting should be conducted to ensure minimum dilution as this will determine the value of the final product. Blasting of the rock part of the face will follow the extraction of the vein. Blast pattern may be varied depending on the face specifics such as the fracture pattern, graphite mineralization etc. As the vein width of vein type graphite occurrences is characterized by high variability, drifting should continue to a distance decided by the geologist. Face mucking should be carried out taking extreme care to maximize recovery and minimize dilution.

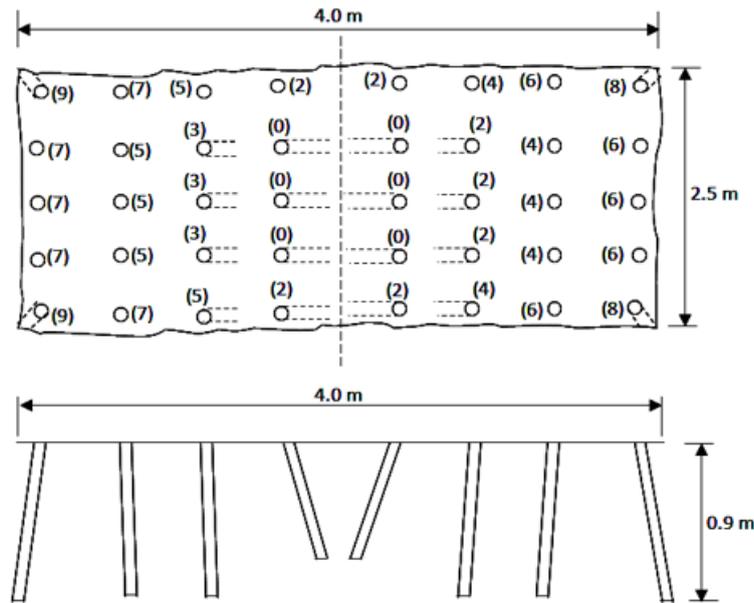
The Cut-hole Round constitutes a Wedge-Cut. Maxim8m drilling depth per round is recommended 0.9 m. Firing pattern of the total round is shown below.

Figure - 2.4.1.12(c): Winze plan view and sectionalized view

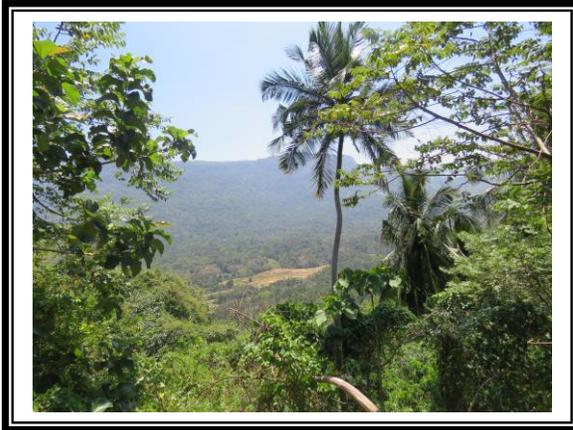
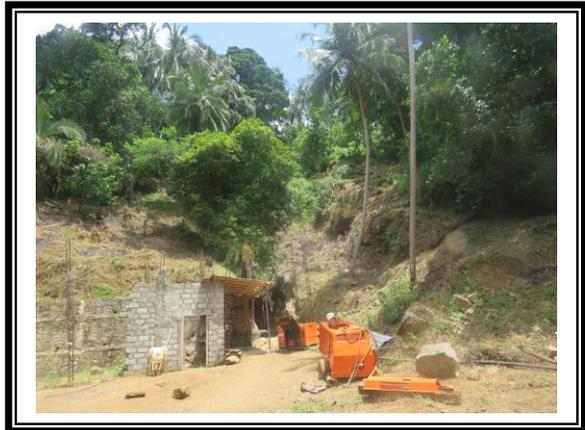
**Plate – 3.1.1.1:** Presence of ridge and valley topography in and around the project area

Physiographically, the area covered by the proposed project and its surrounding belongs to middle peneplain of Sri Lanka. The relief of the area around project site varies from 300 – 633m a.m.s.l, (Figures – 3.1.1.1 & 3.1.1.1A). Presence of ridge and valley topography is a characteristic feature encountered in and around the project area (Figures – 3.1.1.1 & 3.1.1.1A and Plate – 3.1.1.1). The proposed mine is situated on the E directed downward slope of the N-S trending ridge structure (Plate – 3.1.1.1A).

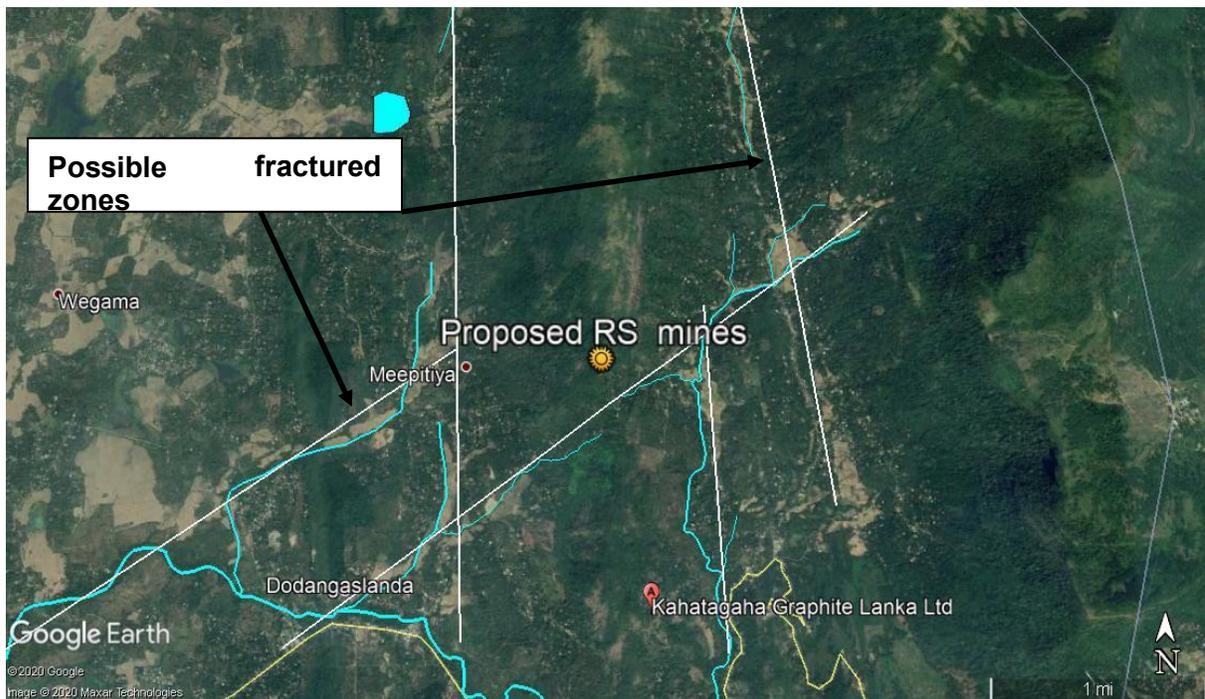
**Figure - 3.1.1.3.1:** Structural Geological features on satellite image in and around the Proposed RS Graphite Mining Site, Maduragoda, Dodangaslanda

Hydrogeologically, these water bearing fractured formation acts as semi confined aquifer. The groundwater in these fractured zones is recharged from the rain. During the field, it is noted that one hand pump deep well has been constructed about 500 m away from the proposed RS graphite mining site towards SE direction. This tube well located along the NS oriented fractured zone of the study area has been tested and transmissivity of the fractured formation is about 15m<sup>2</sup>/day.

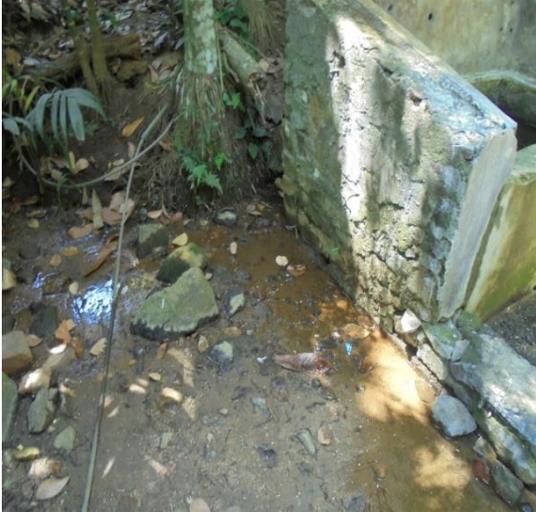
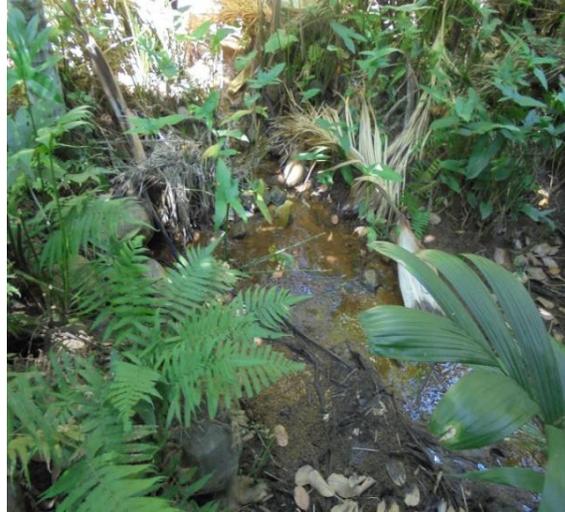
**Plate - 3.1.1.3.2:** Groundwater oozing area and discharging of groundwater along the minor stream (A) close to the minor road of Maduragoda – Kotuhena, Dodangaslanda.

The available groundwater in lower part of overburden in hilly area flows to the low elevated areas until they added to groundwater table or as oozing through interface between rock and lower part of the overburden along the depressions. Groundwater oozing condition could be seen in some places (two places) along the pathway of minor stream (A) at upstream and downstream areas close to minor road of Maduragoda - Kotuhena. The total discharging quantity is about less than 10 liter/minute during the investigation period (Plate - 3.1.1.3.2).

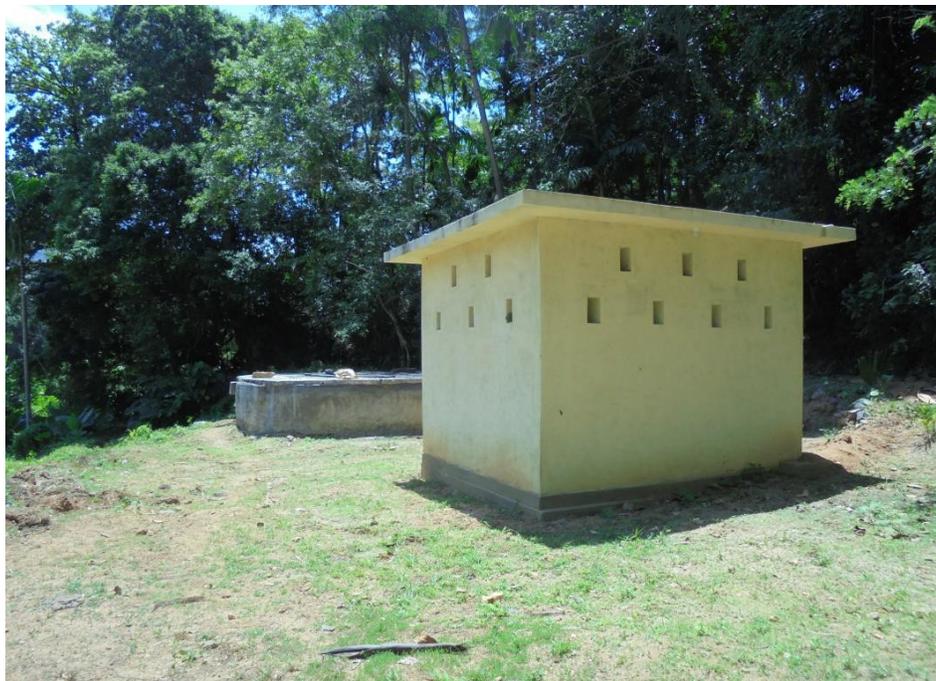
**Plate - 3.1.1.3.2a:** The constructed large diameter dug well (DW10) and pump house for the proposed CBO based village WSS within Project area in Maduragoda

The results indicated that groundwater potential in hilly area and areas close to Kuda Oya are different and relatively higher groundwater potential are expected at the area close to the Kuda Oya and paddy lands than hilly and slope areas. The lower part of overburden in these areas is suitable for the construction of large diameter dug wells for extraction of groundwater. It was noted that a large diameter dug well (DW10) has been constructed at the area closer to the paddy land to supply water to the village for drinking purposes and construction of other structures of CBO based village Water Supply Schemes (WSS) is in progressed (Plate - 3.1.1.3.2a).

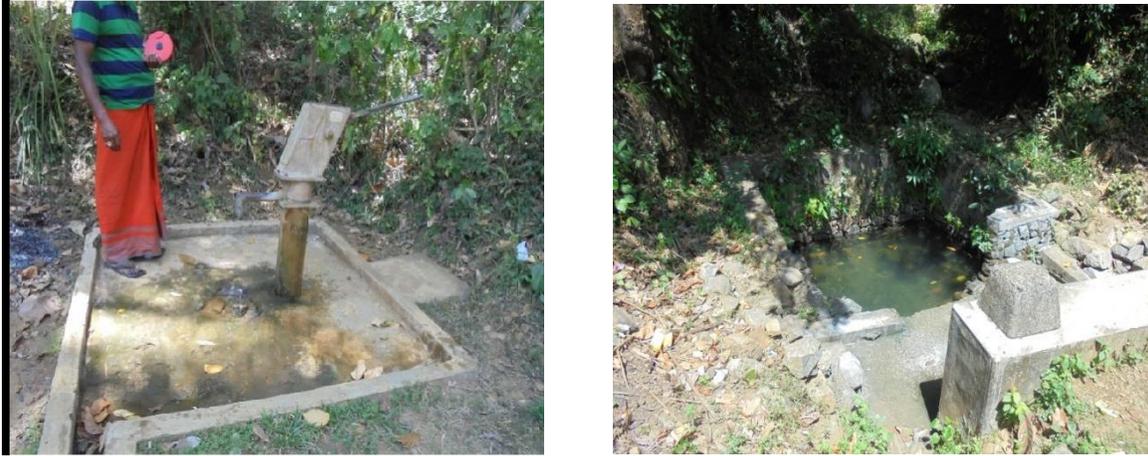
**Plate - 3.1.1.3.2b:** Two visited wells (DW1 and TW1) within the project area, Maduragoda, Dodangaslanda

Several shallow protected and unprotected dug wells are located within study area around proposed graphite mine. The visited wells are shown in Figure - 3.1.1.3.2) and all the available dug wells in hilly and slope areas are located at the area very closer to minor stream (A) and other minor streams. The details of the visited dug wells are given in the Table - 3.1.1.3.2a. The distance to the dug wells of DW1 and DW12 from proposed graphite mine are 220m and 530m, respectively. The photos of visited wells are given in the Plate - 3.1.1.3.2b.

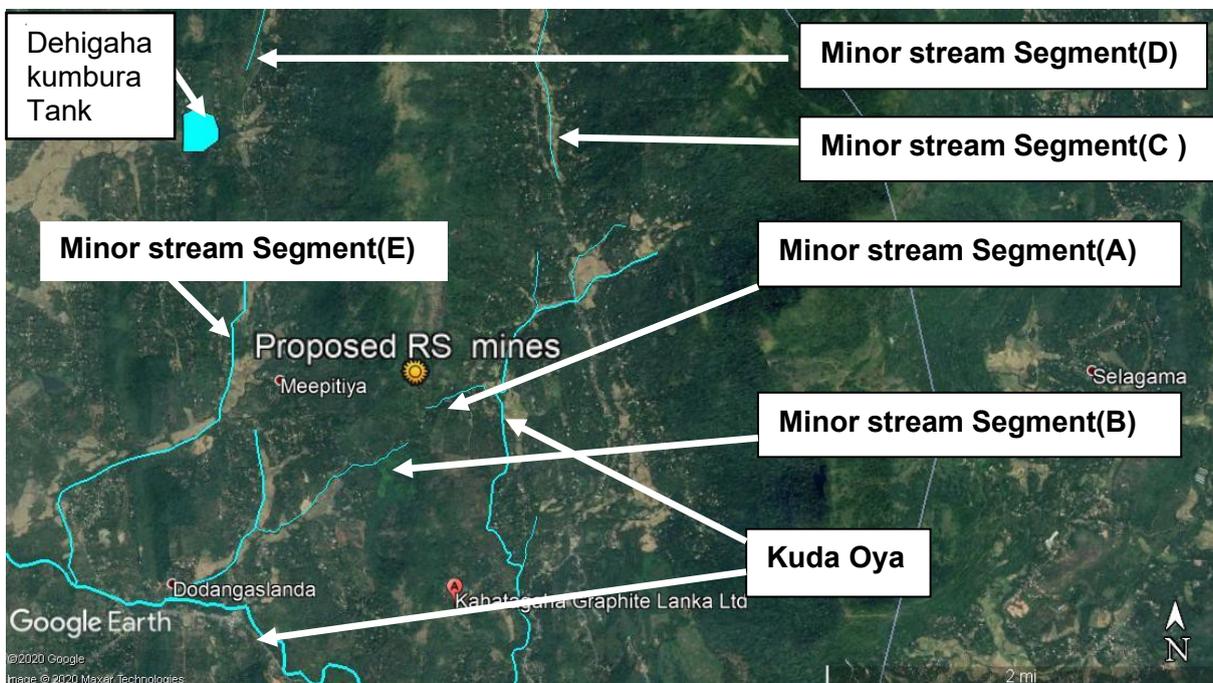
**Figure - 3.1.1.3.3:** Location map of the surface water bodies at the study area Maduragoda, Dodangaslanda

Water Body	Distance from RS mining site (m)	Water Body	Distance from RS mining site(m)
Kuda Oya	750	Minor stream(D)	2800
Minor stream(A)	220	Minor stream(E)	1500
Minor stream(B)	400	Dehigahakubura tank	2500
Minor stream(C)	2000

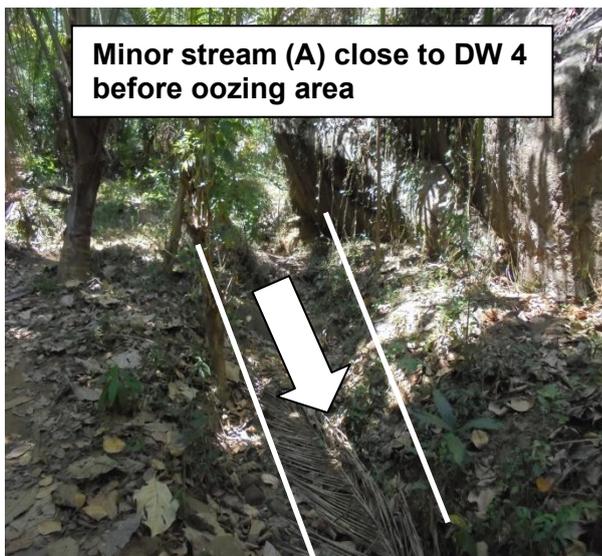
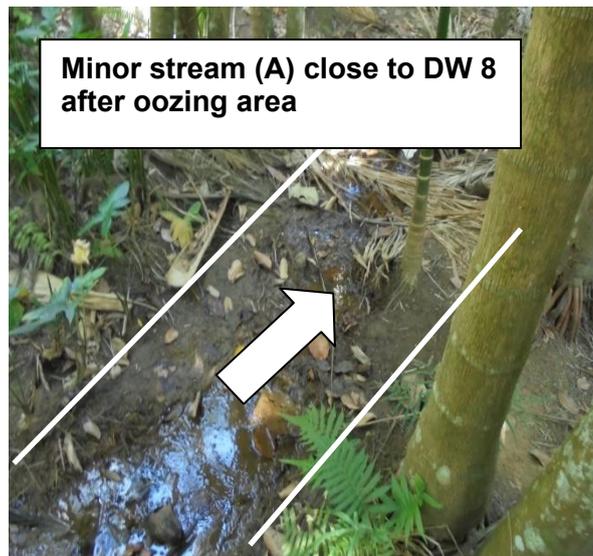
**Plate - 3.1.1.3.3a:** Photos of the seasonal minor stream (A) before and after the oozing area

It is noted that all seasonal minor streams except minor streams (C and D) flow to Kuda Oya. Seasonal minor streams (C and D) flow to Kibulwana Oya. The overland flow of proposed RS mining project site flows to Kuda Oya through seasonal minor streams (A) and (B). The conditions of the seasonal minor stream (A) are given in Plate - 3.1.1.3.3a.

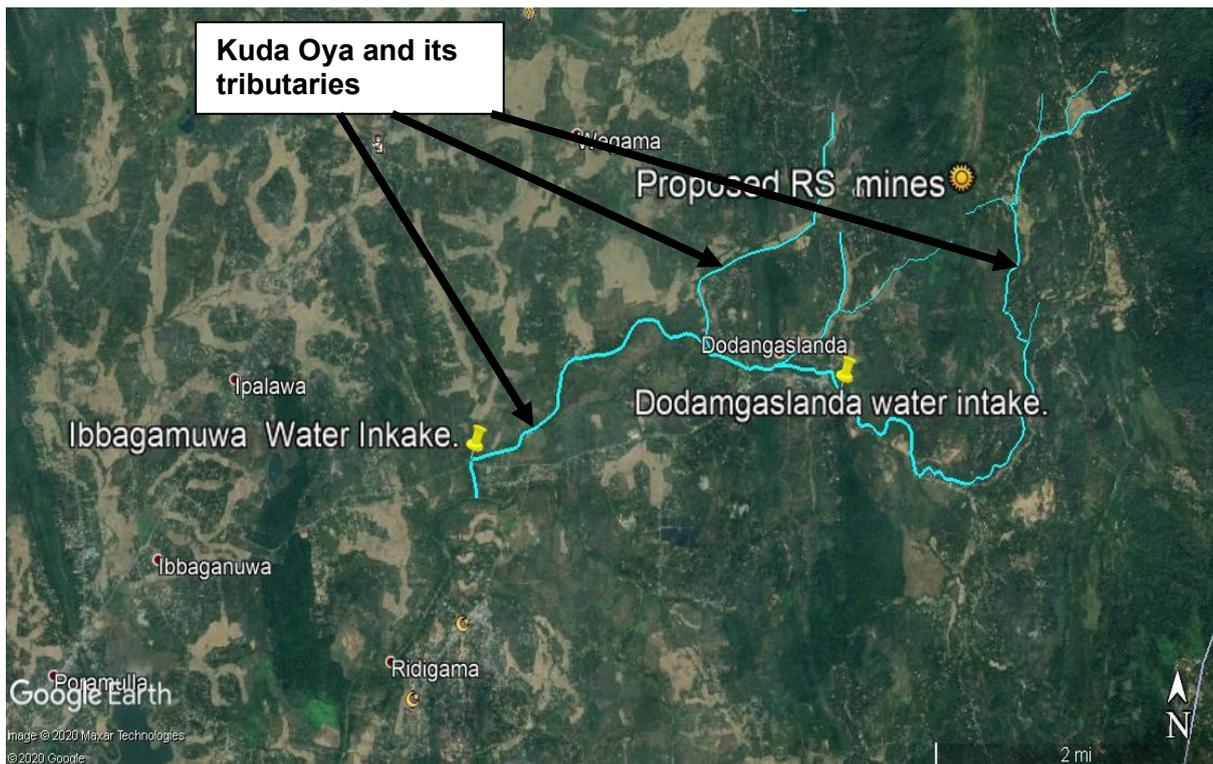
**Figure - 3.1.1.3.4:** Kuda Oya and its tributaries with water supply intakes of Ibbagamuwa and Dodangaslanda

The surface water in Kuda Oya is used for drinking, domestic, and paddy fields. All seasonal minor streams mainly used for the paddy field. It is noted that water in the Kuda Oya has been taped in two places to extract water for the Dodangaslanda and Ibbagamuwa WSSs. The distance from the proposed RS graphite mining site to Dodangaslanda and Ibbagamuwa water supply intakes are about 3 km and 6.5 km, respectively. The location map of the Dodangaslanda and Ibbagamuwa water supply intakes with proposed RS graphite mining site are given in Figure - 3.1.1.3.4.

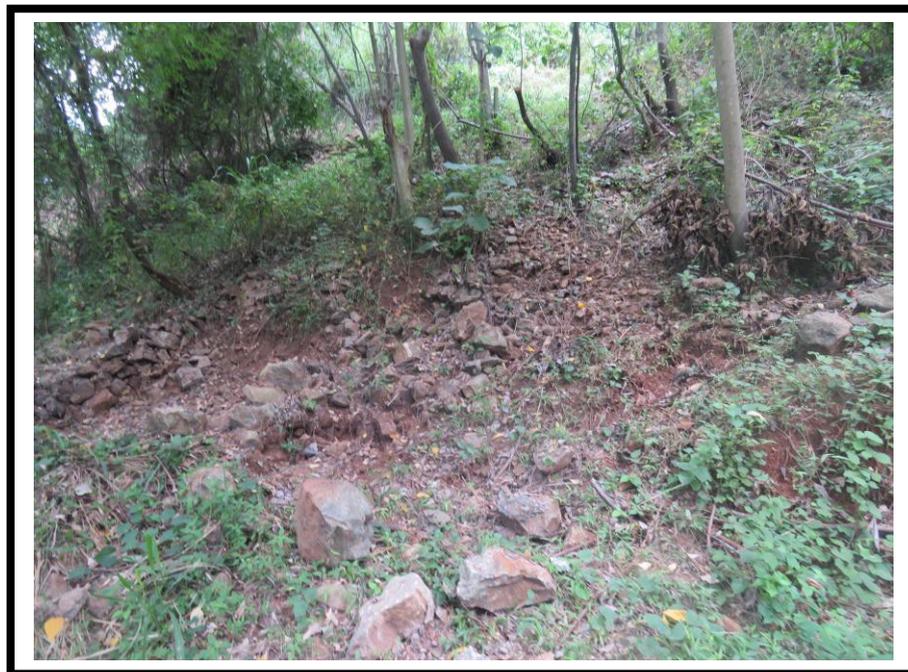
**Plate – 3.1.1.3.6a:** Presence of dumped rock boulders during previous graphite mining activities at places on the top of the overburden cover

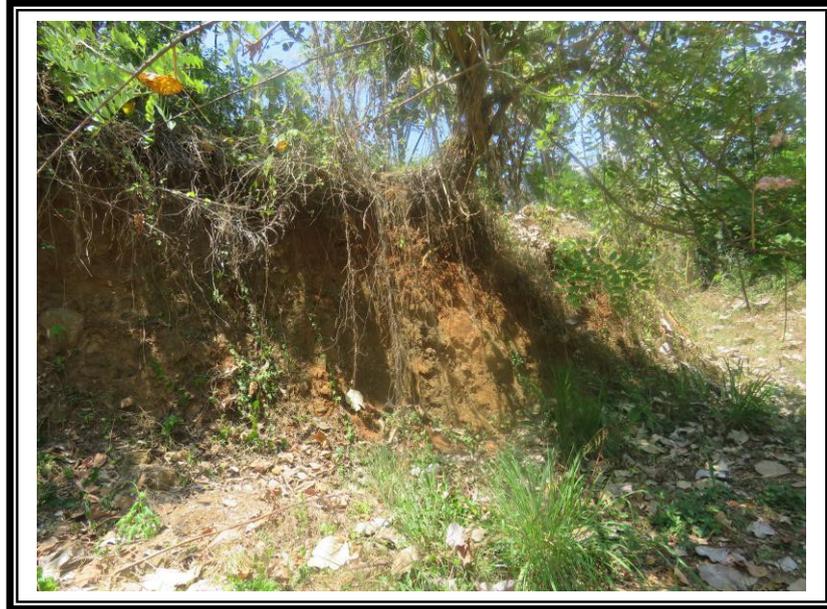
During the previous development of private access road, leading to the mine entrance, hill slope embankment had been disturbed up to 3m height. As a result, minor slope collapsing was occurred at the roadside slope embankment (Plate – 3.1.1.3.6b)

**Plate – 3.1.1.3.6b:** Minor collapsing of roadside slope embankment at place along the access road

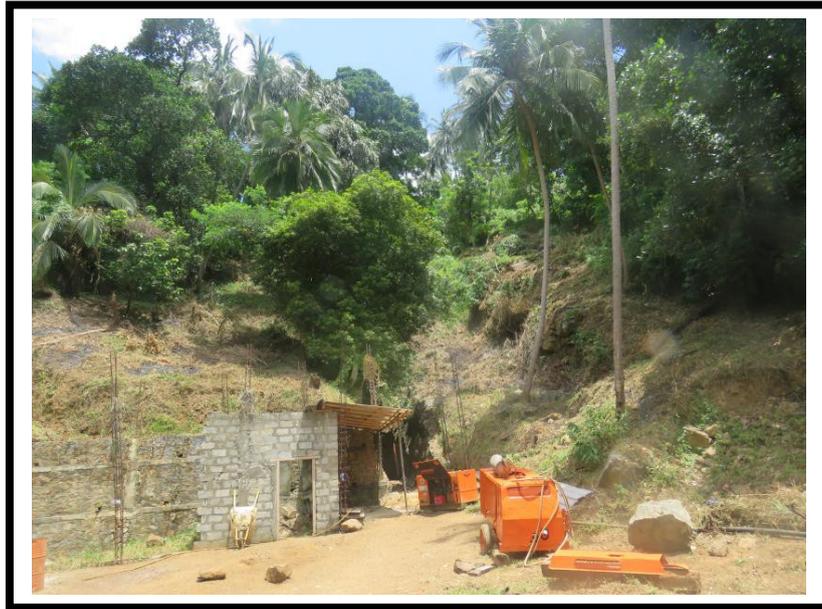
**Plate – 3.1.1.3.6c:** Overburden cover on the hill slope around the mine entrance had been disturbed to some extent up to the bed rock level

In addition, during previous mining activities, overburden cover on the hill slope around the mine entrance had also been disturbed to some extent up to the bed rock level (Plate – 3.1.1.3.6c) in order to open up the mine entrance.

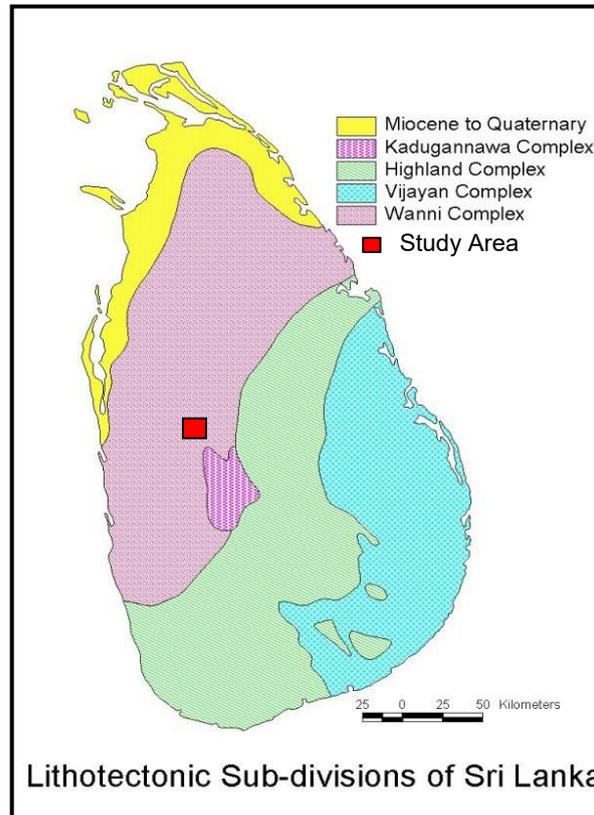
**Figure – 3.1.4:** Simplified Geological Map of Sri Lanka,  
note: Study area is highlighted in red colour box

The dominant rocks in the area are garnetiferous quartzofeldspathic gneiss, charnockitic gneiss, charnockitic biotite gneiss, quartzite, and hornblende biotite gneiss (Fig. - 3.1.4A). Present study of the graphite mineralization at RS Mine revealed that the veins are found in garnetiferous quartzofeldspathic gneiss and charnockitic gneiss rock formations (Fig. – 3.1.4B).

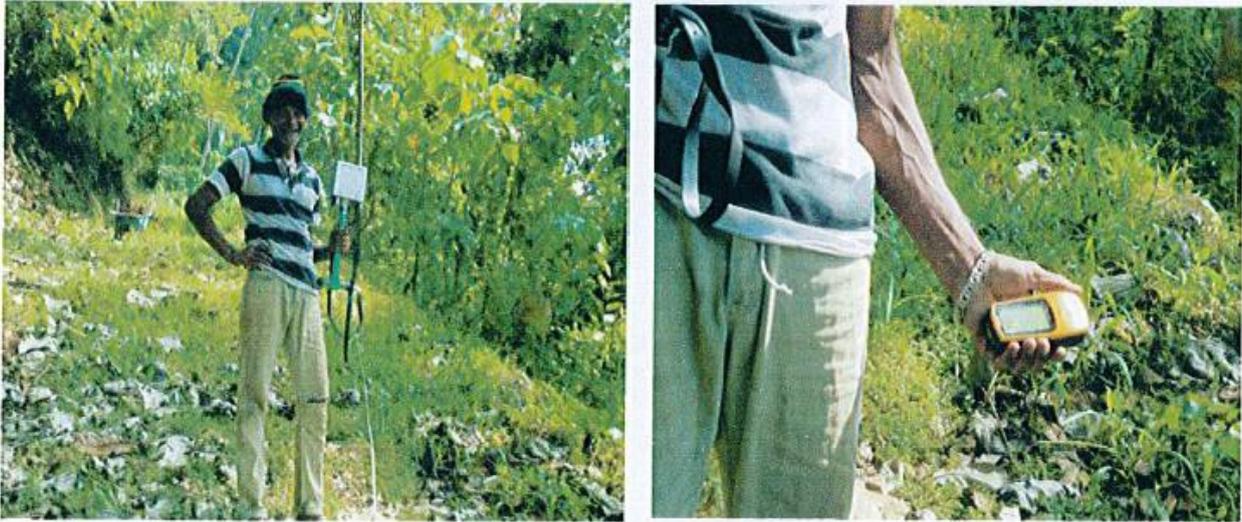
**Plate – 3.1.4:** Getting Field Measurements using EM-16 (VLF) Instrument

VLF instrument was used to carry out the ground geophysical survey (Plate – 3.1.4).

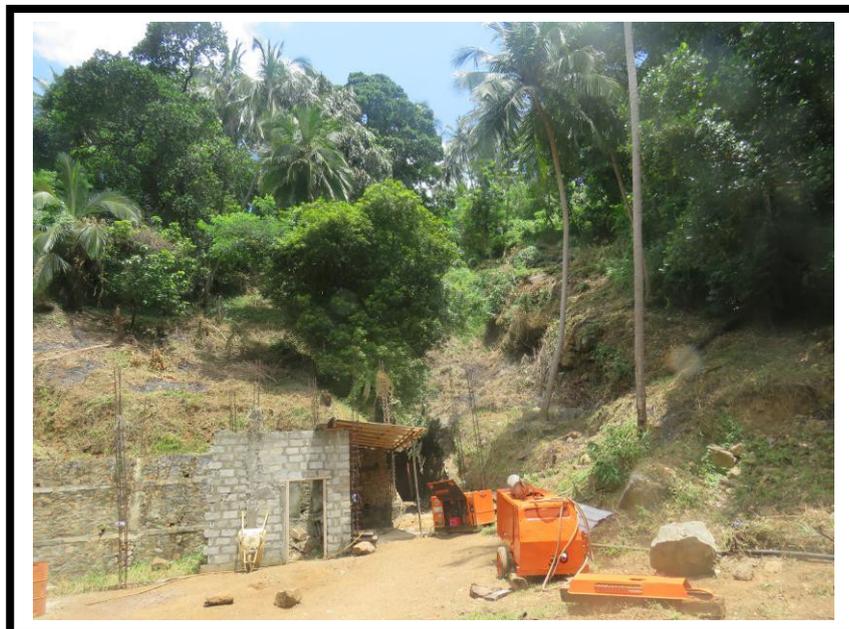
By viewing the hill slope around the proposed mining site, it was appeared that some hill slope clearing activities had been performed when initiating the earlier mining activities as well as current mine preparation activities (Plate – 4.1.1). There was a possibility of uprooting few tree species within the hill slope around the mine structure during the development of mine structure in earlier days. No further uprooting of trees is required within the hill slope of the area covered by the mine structure, during the proposed mining activities.

**Plate – 4.1.1:** Photograph showing existing land use pattern immediate around the mine hill slope. Also note some land clearance activities performed around the mine hill slope

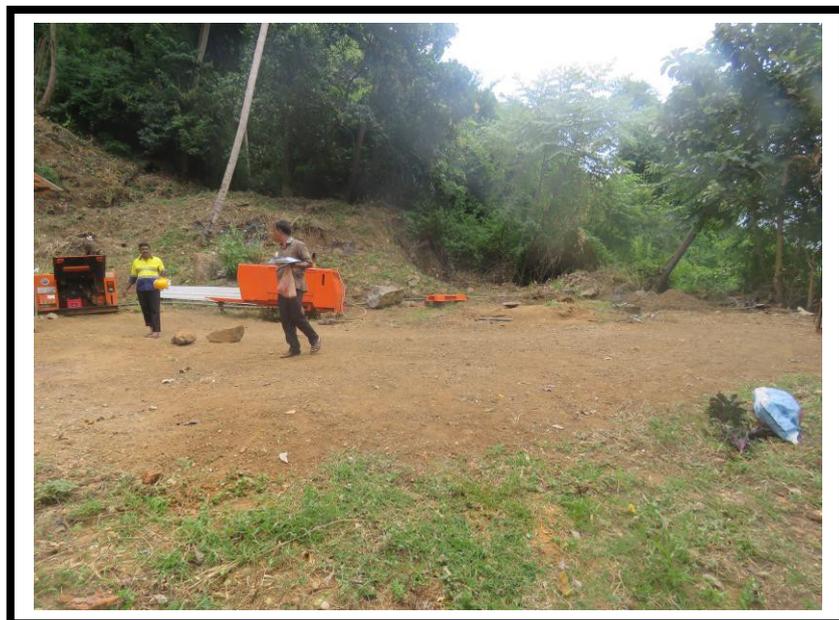
**Plate – 4.1.1A:** Horizontal ground area prepared in front of the mine entrance as stockpiling sites

When commencing mining activities, the company has cleared the hilly ground area around the mouth of the mine structure. During the cleaning process, the company had prepared a horizontal ground area in front of the mine mouth by excavating the ridge slope, in order to temporarily stockpile mined out graphite fragments, to separate graphite lumps from blasted rock fragments by manual chipping and to keep graphite veins bearing rock fragments until graphite lumps are separated by manual chipping (Plate – 4.1.1A).

Proposed stockpiling sites are selected in front of the mine entrance. During earlier mining activities as well as recent exploration activities, substantial area has been prepared to stockpile mined out graphite fragments, to separate graphite lumps from blasted rock fragments by manual chipping and to keep graphite veins bearing rock fragments until graphite lumps are separated by manual chipping. In addition, these stockpiling areas are expected to be enlarged by cutting right hill slope. Hence, soil erosion process could be expected from these cut slope sections as well as soil exposed sections. Hence, it is recommended to level / slope (in 1:4 ratio) and grass turfed covering the boundary sections of these sites in order to cover these soil exposed sections.

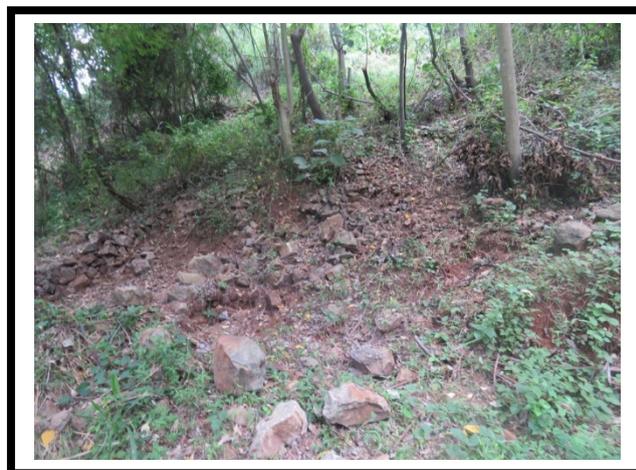
**Plate – 4.2.1.1a:** Presence of dumped rock boulders during previous graphite mining activities at places on the top of the overburden cover

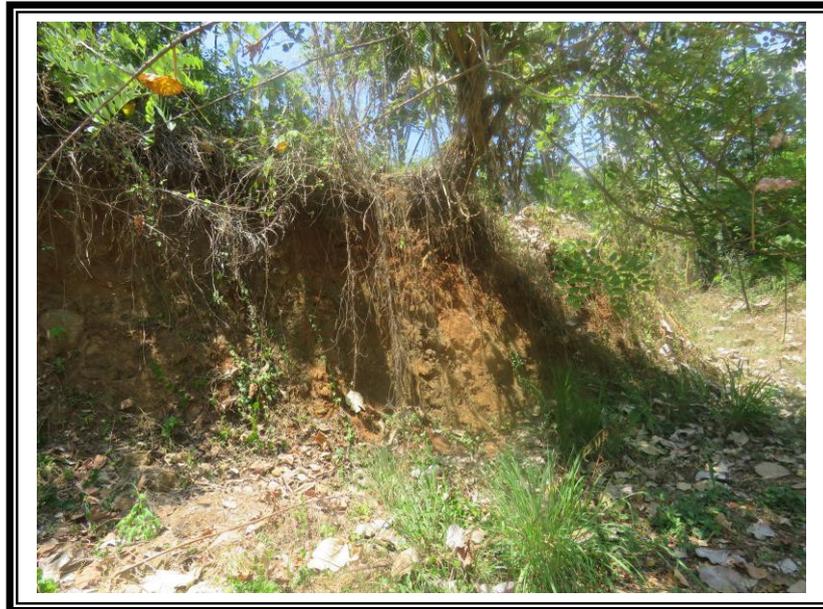
During the previous development of private access road, leading to the mine entrance, hill slope embankment had been disturbed upto 3m height. As a result, minor slope collapsing was occurred at the roadside slope embankment (Plate – 4.2.1.1b)

**Plate – 4.2.1.1b:** Minor collapsing of roadside slope embankment at place along the access road

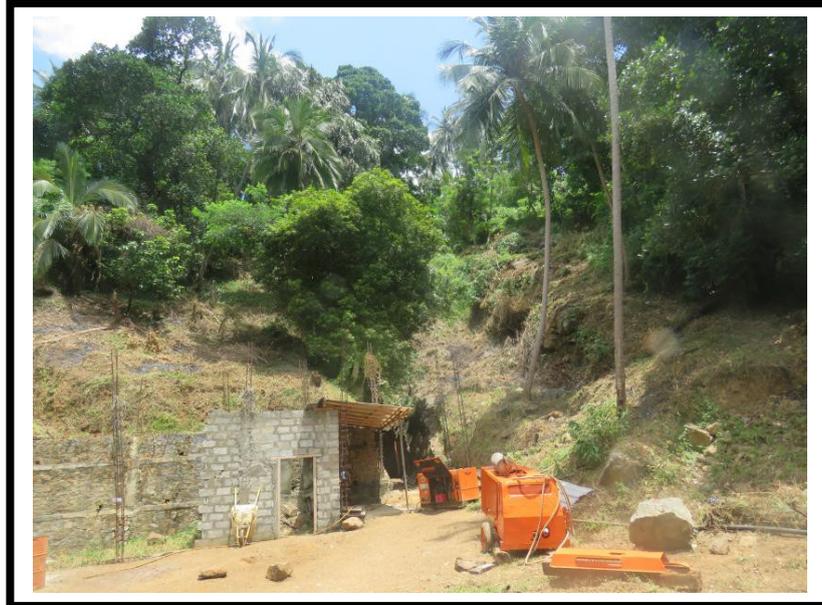
**Plate – 4.2.1.1c:** Overburden cover on the hill slope around the mine entrance had been disturbed to some extent up to the bed rock level

In addition, during previous mining activities, overburden cover on the hill slope around the mine entrance had also been disturbed to some extent up to the bed rock level (Plate – 4.2.1.1c) in order to open up the mine entrance.

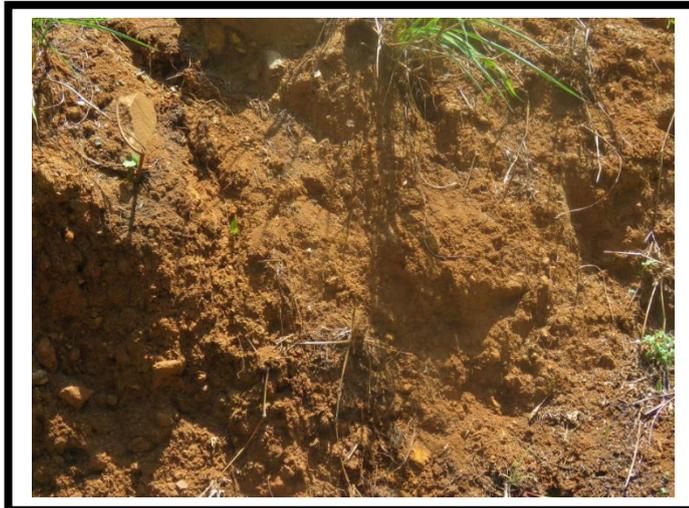
Thickness of the overburden cover on the top of the project area varies from 0 – 5m and it comprises of orange, brown lateritic soil cover (Plate – 5.1.1) and residual soil cover & highly to completely weathered rock formation of garnetiferous quartzofeldspathic gneiss and charnockitic gneiss rocks. At places dumped rock boulders during previous graphite mining activities are also identified (Plate - 5.1.1a). At some places of the hill slope, unstable rock boulders exit. Hence, it is highly recommended to remove such boulders, prior to commencement of the mine with the advice of an experienced landslide specialist.

**Plate – 5.1.1:** Orange brown lateritic overburden soil cover within the project area

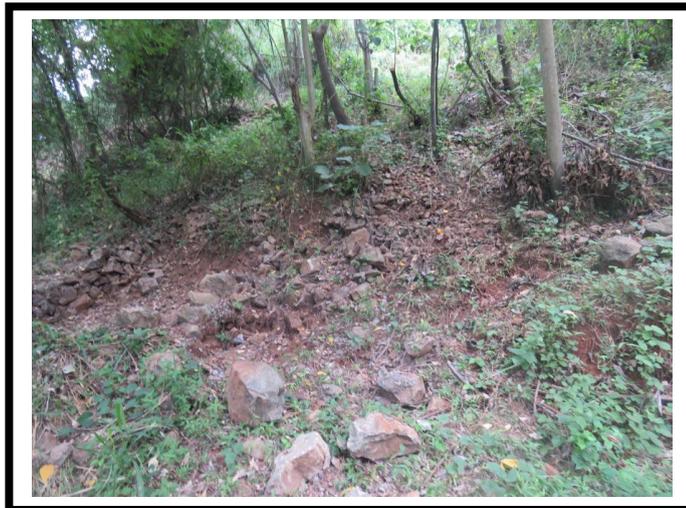
**Plate – 5.1.1a:** Presence of dumped rock boulders during previous graphite mining activities at places on the top of the overburden cover
