## **CHAPTER - 1**

### **INTRODUCTION**

#### **1.1 Background to the Proposed Project**

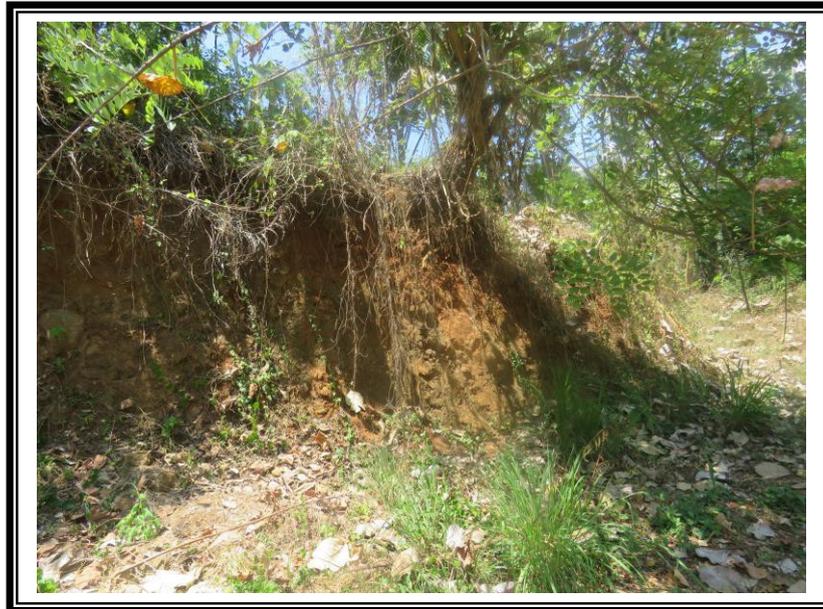
During the previous development of private access road, leading to the mine entrance, hill slope embankment had been disturbed up to 3m height. As a result, minor slope collapsing was occurred at the roadside slope embankment (Plate – 5.1.1b)

**Plate – 5.1.1b:** Minor collapsing of roadside slope embankment at place along the access road

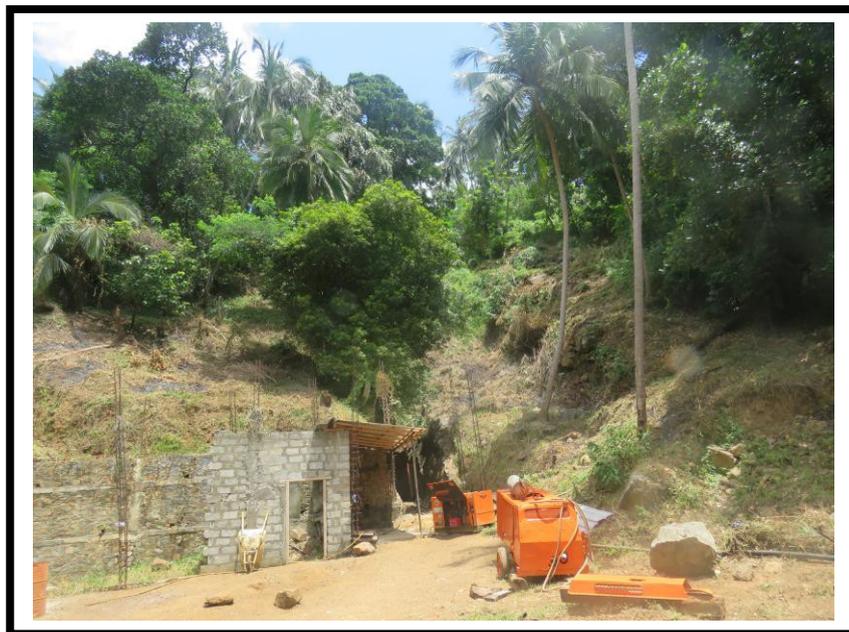
By viewing the hill slope around the proposed mining site, it was appeared that some hill slope clearing activities had been performed when initiating the earlier mining activities as well as current mine preparation activities (Plate – 5.1.2). There was a possibility of uprooting few tree species within the hill slope around the mine structure during the development of mine structure in earlier days. No further uprooting of trees is required within the hill slope of the area covered by the mine structure, during the proposed mining activities.

**Plate – 5.1.2:** Photograph showing existing land use pattern immediate around the mine hill slope. Also note some land clearance activities performed around the mine hill slope

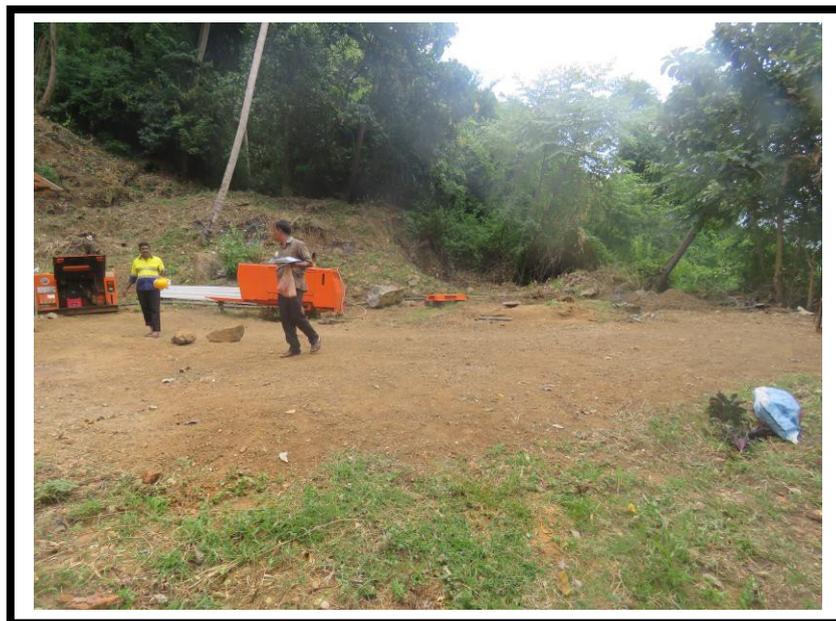
**Plate – 5.1.2A:** Horizontal ground area prepared in front of the mine entrance as stockpiling sites

When commencing mining activities, the company has cleared the hilly ground area around the mouth of the mine structure. During the cleaning process, the company had prepared a horizontal ground area in front of the mine mouth by excavating the ridge slope, in order to temporally stockpile mined out graphite fragments, to separate graphite lumps from blasted rock fragments by manual chipping and to keep graphite veins bearing rock fragments until graphite lumps are separated by manual chipping (Plate – 5.1.2A).

Proposed stockpiling sites are selected in front of the mine entrance. During earlier mining activities as well as recent exploration activities, substantial area has been prepared to stockpile mined out graphite fragments, to separate graphite lumps from blasted rock fragments by manual chipping and to keep graphite veins bearing rock fragments until graphite lumps are separated by manual chipping. In addition, these stockpiling areas are expected to be enlarged by cutting right hill slope. Hence, soil erosion process could be expected from these cut slope sections as well as soil

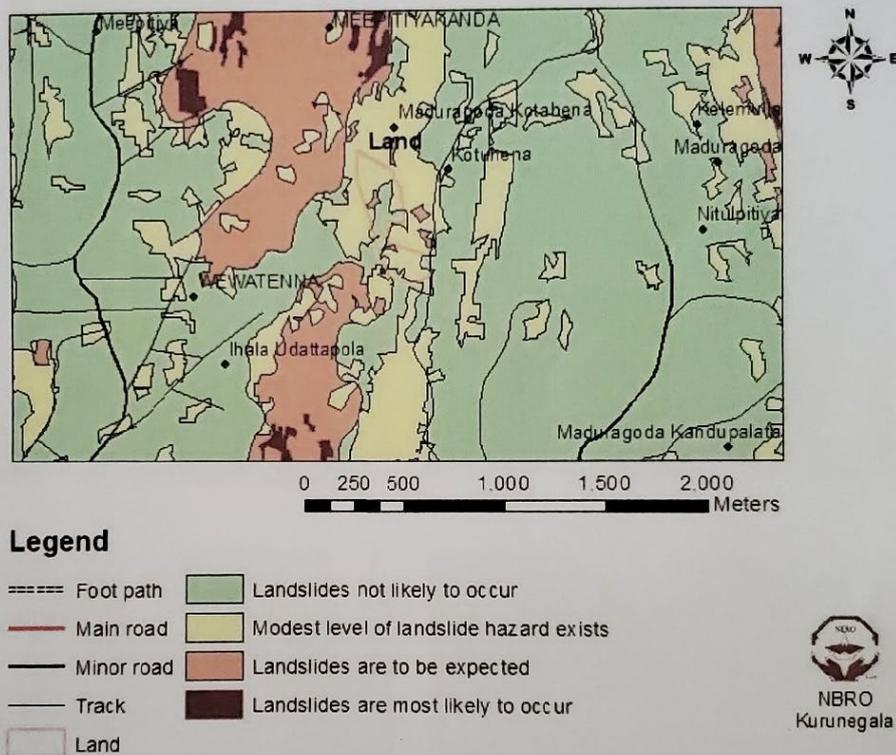
**Fig.2: Landslide hazard zonation map of the area**

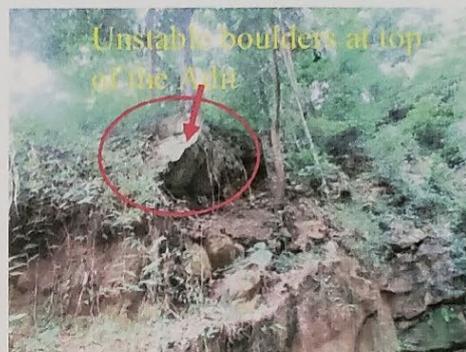
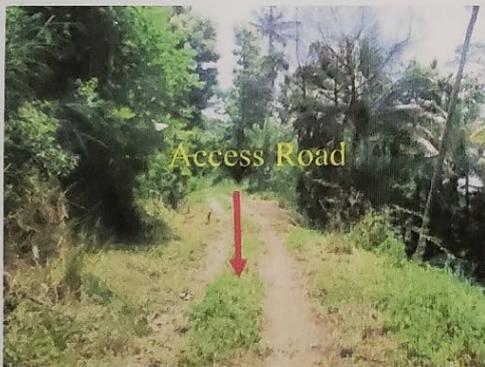
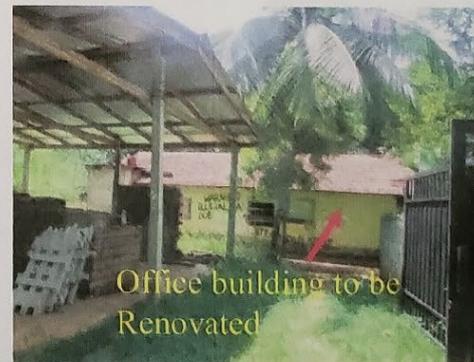
**Fig.3: Photographs of the mine and surrounding area**

3. Project area is a forested land having a general gradient of about 25°.
4. Bedrock can be categorized as quartzo-feldspathic gneiss and according to the visual observations, graphite vein is intruded in N70°W / 70°SW (Strike / Dip) joint plane.
5. The mine has been started in 2007 and currently been abandoned. Adit, mine shaft and cross cuts are available as shown in Fig.5.

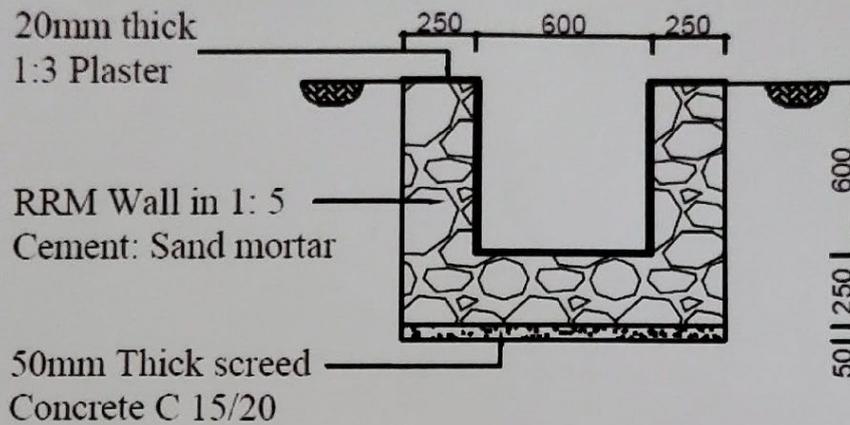
**Fig.7: Method of access road development and typical 0.6m×0.6m side drain details**

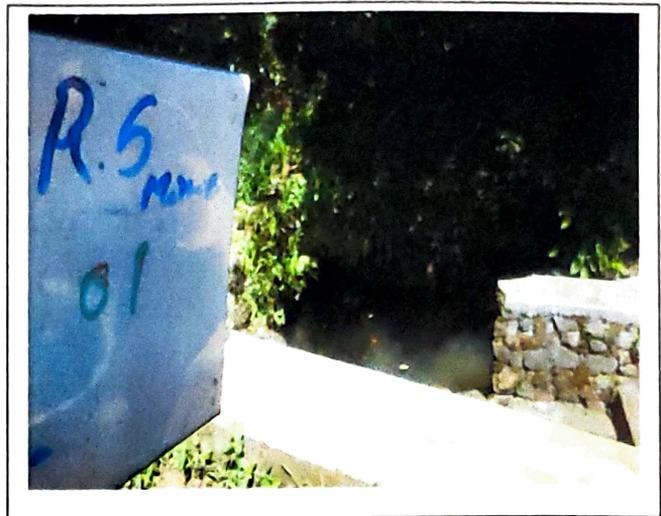
(1) Identification number of house:	H 01	
(2) Photo notation:	H <sup>RS Mine</sup> -01-01	
(3) Approximate age of the house:	-	
(4) Details of the land in which house was built on:	Existing ground	
(5) Existing structural detail		
5.1 Detail of the roof:	-	
5.2 Detail of the walls:	5.2.1 Material type:	-
	5.2.2 Thickness:	-
5.3 Detail of the plaster:	-	
5.4 Detail of the windows:	-	
5.5 Details of floor	-	
5.6 Details of foundation	-

Pre-Survey			Remarks
Crack No	Length (cm)	Thickness (mm)	
C 01	30*25		Crack on the top

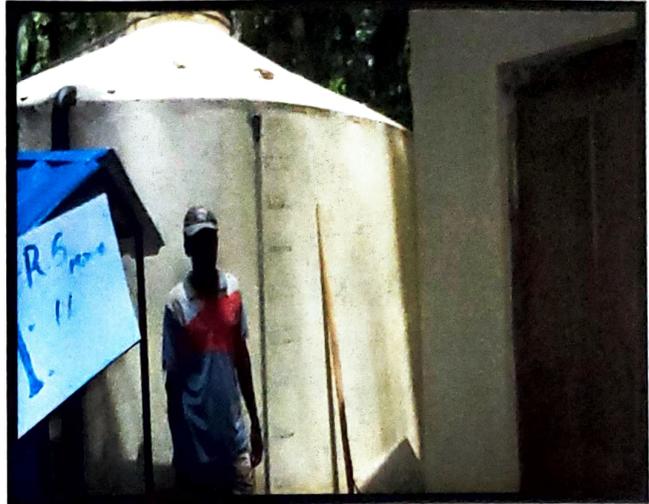
**Location** : RS Mine-Maduragoda  
**House No** : H 11  
**Name** : Storage Tank  
**Address** : Kotuhena,Udaththapala  
 Maduragoda  
**GPS Coordinate:**  
 E – 174911  
 N – 265091

<b>(1) Identification number of house:</b>	H 11	
<b>(2) Photo notation:</b>	H <sup>RS Mine</sup> 11	
<b>(3) Approximate age of the house:</b>	01 years.	
<b>(4) Details of the land in which house was built on:</b>	Existing ground	
<b>(5) Existing structural detail</b>		
<b>5.1 Detail of the roof:</b>	Slab	
<b>5.2 Detail of the walls:</b>	<b>5.2.1 Material type:</b>	Bricks
	<b>5.2.2 Thickness :</b>	-
<b>5.3 Detail of the plaster:</b>	Both side	
<b>5.4 Detail of the windows:</b>	-	
<b>5.5 Details of floor</b>	Cemented	
<b>5.6 Details of foundation</b>	Rubble & Masonry

<b>(6) Details of cracks at the Pre-Survey</b>			
<b>Pre-Survey</b>			<b>Remarks</b>
<b>Crack No</b>	<b>Length (cm)</b>	<b>Thickness (mm)</b>	
Note	-	-	No cracked & damaged at inspection time

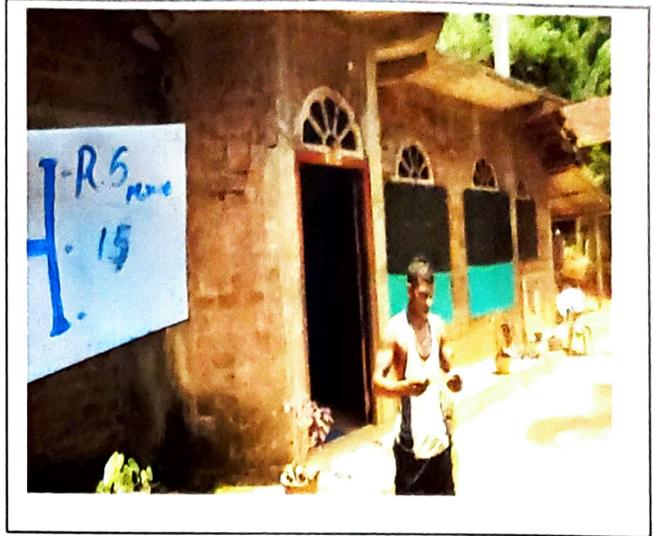
**Location** :RS Mine-Maduragoda  
**House No** : H 15  
**Name** :P.D Athula weerasinghe  
**Address** :Udaththapala,Maduragoda  
**GPS Coordinate:**

<b>(1) Identification number of house:</b>	H 15	
<b>(2) Photo notation:</b>	H <sup>RS Mine</sup> -15-01	
<b>(3) Approximate age of the house:</b>	12 years	
<b>(4) Details of the land in which house was built on:</b>	Existing ground	
<b>(5) Existing structural detail</b>		
<b>5.1 Detail of the roof:</b>	Roof tiles standard& Slab	
<b>5.2 Detail of the walls:</b>	<b>5.2.1 Material type:</b>	Bricks& Cement blocks
	<b>5.2.2 Thickness:</b>	-
<b>5.3 Detail of the plaster:</b>	Some part	
<b>5.4 Detail of the windows:</b>	Window frame only	
<b>5.5 Details of floor</b>	Concreted& Soil Compacted	
<b>5.6 Details of foundation</b>	Rubble & Masonry

<b>(6) Details of cracks at the Pre-Survey</b>			
<b>Pre-Survey</b>			<b>Remarks</b>
<b>Crack No</b>	<b>Length (cm)</b>	<b>Thickness (mm)</b>	
C 01	82	01	Downward from top to bottom on the wall –both side
F	-	-	Floor has been damaged

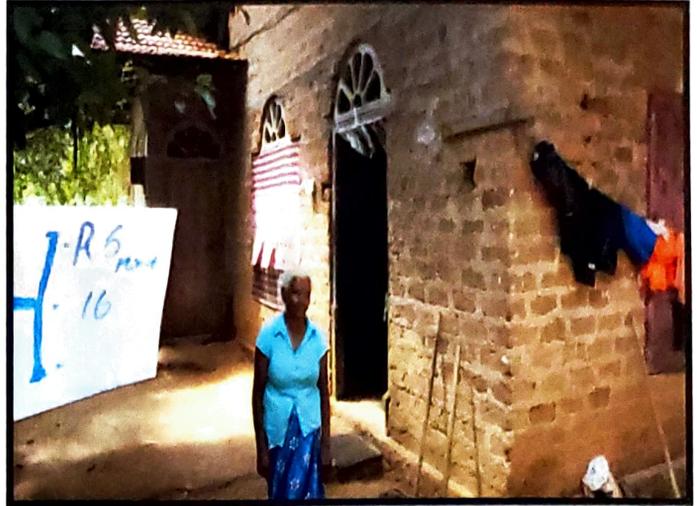
**Location** : RS Mine-Maduragoda  
**House No** : H 16  
**Name** : Upul Shantha Gunasinghe  
**Address** : Kotuhena, Udaththapala  
 Maduragoda  
**GPS Coordinate:**

<b>(1) Identification number of house:</b>	H 16	
<b>(2) Photo notation:</b>	H <sup>RS Mine</sup> 16	
<b>(3) Approximate age of the house:</b>	10 years.	
<b>(4) Details of the land in which house was built on:</b>	Existing ground	
<b>(5) Existing structural detail</b>		
<b>5.1 Detail of the roof:</b>	Roof tiles standard	
<b>5.2 Detail of the walls:</b>	<b>5.2.1 Material type:</b>	Bricks
	<b>5.2.2 Thickness :</b>	130mm
<b>5.3 Detail of the plaster:</b>	Some part	
<b>5.4 Detail of the windows:</b>	Window frame only	
<b>5.5 Details of floor</b>	Concreted	
<b>5.6 Details of foundation</b>	Rubble & Masonry

<b>(6) Details of cracks at the Pre-Survey</b>			
<b>Pre-Survey</b>			<b>Remarks</b>
<b>Crack No</b>	<b>Length (cm)</b>	<b>Thickness (mm)</b>	
Note	-	-	No cracked & damaged at inspection time

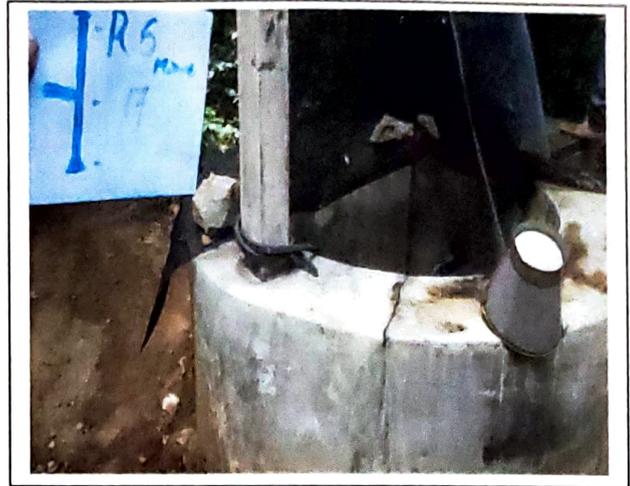
<b>(1) Identification number of house:</b>		H 17
<b>(2) Photo notation:</b>		H <sup>RS Mine</sup> -17-01
<b>(3) Approximate age of the house:</b>		15 years
<b>(4) Details of the land in which house was built on:</b>		Existing ground
<b>(5) Existing structural detail</b>		
<b>5.1 Detail of the roof:</b>	-	
<b>5.2 Detail of the walls:</b>	<b>5.2.1 Material type:</b>	stones
	<b>5.2.2 Thickness:</b>	-
<b>5.3 Detail of the plaster:</b>	-	
<b>5.4 Detail of the windows:</b>	-	
<b>5.5 Details of floor</b>	-	
<b>5.6 Details of foundation</b>	-

<b>(6) Details of cracks at the Pre-Survey</b>			
<b>Pre-Survey</b>			<b>Remarks</b>
<b>Crack No</b>	<b>Length (cm)</b>	<b>Thickness (mm)</b>	
C 01	49	01	Crack on the top

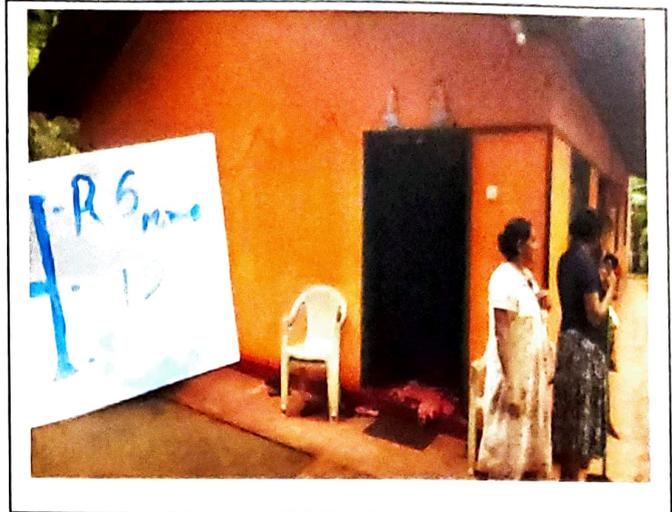
Location :RS Mine-Maduragoda  
 House No : H 19  
 Name :Seelawathi  
 Address :Udaththapala,Maduragoda  
 GPS Coordinate:  
 E – 174702  
 N – 265097

(1) Identification number of house:	H 19	
(2) Photo notation:	H <sup>RS Mine</sup> -19-23	
(3) Approximate age of the house:	30years	
(4) Details of the land in which house was built on:	Existing ground	
(5) Existing structural detail		
5.1 Detail of the roof:	Roof tiles standard	
5.2 Detail of the walls:	5.2.1 Material type:	Bricks
	5.2.2 Thickness:	-
5.3 Detail of the plaster:	Both side	
5.4 Detail of the windows:	Wooden & Glass	
5.5 Details of floor	Cemented	
5.6 Details of foundation	Rubble & Masonry

<b>(6) Details of cracks at the Pre-Survey</b>			
<b>Pre-Survey</b>			<b>Remarks</b>
<b>Crack No</b>	<b>Length (cm)</b>	<b>Thickness (mm)</b>	
MC 01	29	Minor	Downward from top to bottom on the wall
MC 02	87	Minor	Downward from right side of the window frame
MC 03	143	Minor	Downward from top to bottom along the wall joint
MC 04	43	Minor	Downward from right side of the window frame
MC 05	53	Minor	Downward from top to bottom along the wall joint
MC 06	124	Minor	Downward from top to bottom along the wall joint –both side
MC 07	57	Minor	Downward from middle of the window frame
C 01	108	01	Downward from top to bottom along the wall joint
C 02	103	01	Downward from top to bottom along the wall joint –both side
C 03	216	01	Downward from top to bottom along the wall joint
C 04	142	01	Downward from top to bottom on the wall-both side
P	820*100		Pavement has been cracked
P 01	-	-	Pavement has been damaged

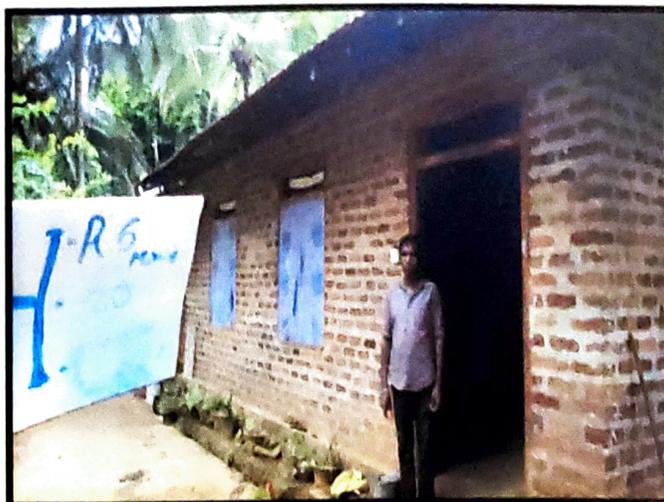
**Location** : RS Mine-Maduragoda  
**House No** : H 20  
**Name** : Swarnathilaka  
**Address** : Kotuhena,Udaththapala  
 Maduragoda  
**GPS Coordinate:**  
 E – 174735  
 N – 265052

<b>(1) Identification number of house:</b>	H 20	
<b>(2) Photo notation:</b>	H <sup>RS Mine</sup> 20	
<b>(3) Approximate age of the house:</b>	06 years.	
<b>(4) Details of the land in which house was built on:</b>	Existing ground	
<b>(5) Existing structural detail</b>		
<b>5.1 Detail of the roof:</b>	Roof tiles standards	
<b>5.2 Detail of the walls:</b>	<b>5.2.1 Material type:</b>	Bricks
	<b>5.2.2 Thickness :</b>	-
<b>5.3 Detail of the plaster:</b>	no	
<b>5.4 Detail of the windows:</b>	Wooden & Glass	
<b>5.5 Details of floor</b>	Concreted	
<b>5.6 Details of foundation</b>	Rubble & Masonry

<b>(6) Details of cracks at the Pre-Survey</b>			
<b>Pre-Survey</b>			<b>Remarks</b>
<b>Crack No</b>	<b>Length (cm)</b>	<b>Thickness (mm)</b>	
Note	-	-	No cracked & damaged at inspection time

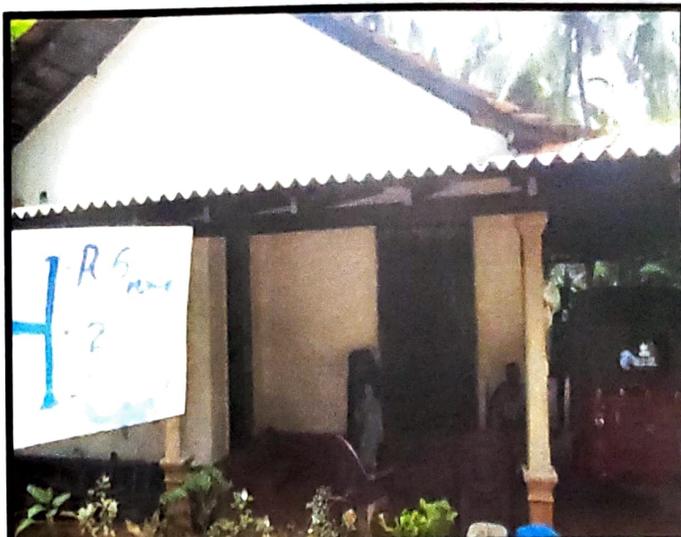
**Location** : RS Mine-Maduragoda  
**House No** : H 22  
**Name** : S.D Chalana Edirisinghe  
**Address** : Kotuhena,Udaththapala  
 Maduragoda  
**GPS Coordinate:**  
 E – 174658  
 N – 265022

<b>(1) Identification number of house:</b>	H 22	
<b>(2) Photo notation:</b>	H <sup>RS Mine</sup> 22-2	
<b>(3) Approximate age of the house:</b>	15 years.	
<b>(4) Details of the land in which house was built on:</b>	Existing ground	
<b>(5) Existing structural detail</b>		
<b>5.1 Detail of the roof:</b>	Asbestos sheet & tiled Standard	
<b>5.2 Detail of the walls:</b>	<b>5.2.1 Material type:</b>	Cement block
	<b>5.2.2 Thickness :</b>	130mm
<b>5.3 Detail of the plaster:</b>	Both side	
<b>5.4 Detail of the windows:</b>	Wooden & Glazed	
<b>5.5 Details of floor</b>	Cemented	
<b>5.6 Details of foundation</b>	Rubble & Masonry

<b>(6) Details of cracks at the Pre-Survey</b>			
<b>Pre-Survey</b>			<b>Remarks</b>
<b>Crack No</b>	<b>Length (cm)</b>	<b>Thickness (mm)</b>	
MC 01	243	Minor	Downward from top to bottom on the wall
MC 02	41	Minor	Downward from top to bottom on the wall
C 01	109	01	Horizontally on the wall
C 02	253	01	Downward from top to bottom on the wall

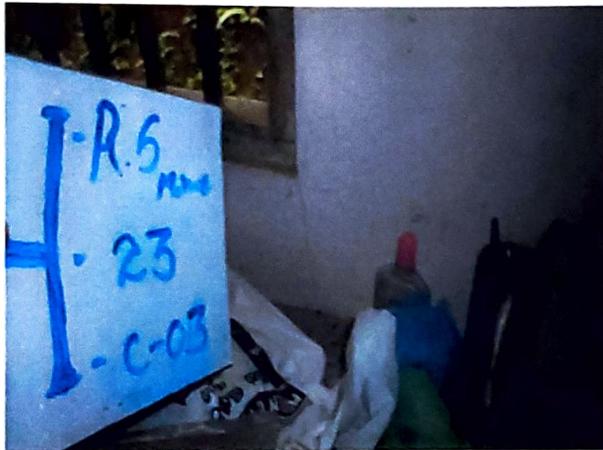
<b>(6) Details of cracks at the Pre-Survey</b>			
<b>Pre-Survey</b>			<b>Remarks</b>
<b>Crack No</b>	<b>Length (cm)</b>	<b>Thickness (mm)</b>	
MC 01	56	Minor	Downward from left side of the window frame
MC 02	27	Minor	Horizontally from right side of the door frame
C 01	59	01	Upward from left side of the door frame- <b>Both side</b>
C 02	70	02	Upward from middle of the window frame- <b>Both side</b>
C 03	86	01	Downward from left side of the window frame- <b>Both side</b>

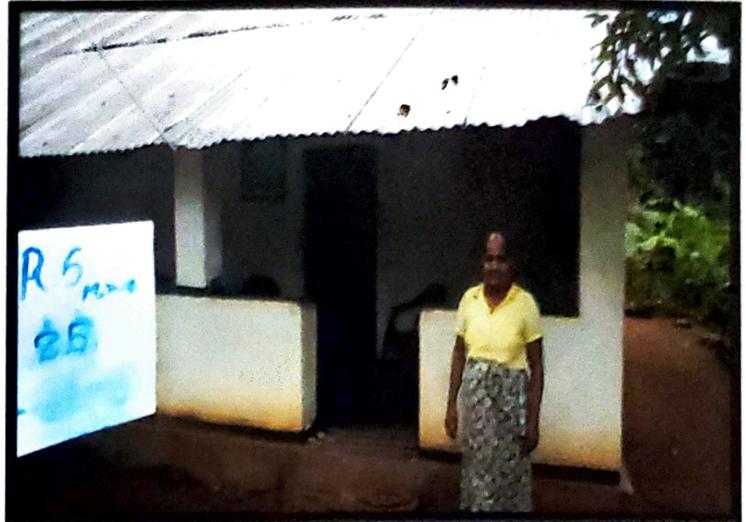
**Location** : RS Mine-Maduragoda  
**House No** : H 25  
**Name** : P.M Dayawathi  
**Address** : Kotuhena,Udaththapala  
 Maduragoda  
**GPS Coordinate:**  
 E - 174637  
 N - 264964

<b>(1) Identification number of house:</b>	H 25	
<b>(2) Photo notation:</b>	H <sup>RS Mine</sup> 25	
<b>(3) Approximate age of the house:</b>	50 years.	
<b>(4) Details of the land in which house was built on:</b>	Existing ground	
<b>(5) Existing structural detail</b>		
<b>5.1 Detail of the roof:</b>	Corrugated sheets	
<b>5.2 Detail of the walls:</b>	<b>5.2.1 Material type:</b>	Daub & wattle
	<b>5.2.2 Thickness :</b>	-
<b>5.3 Detail of the plaster:</b>	No	
<b>5.4 Detail of the windows:</b>	Wooden	
<b>5.5 Details of floor</b>	Cement Grouted	
<b>5.6 Details of foundation</b>	Rubble & Masonry

<b>(6) Details of cracks at the Pre-Survey</b>			
<b>Pre-Survey</b>			<b>Remarks</b>
<b>Crack No</b>	<b>Length (cm)</b>	<b>Thickness (mm)</b>	
Note	-	-	The house was constructed by daub and wattle

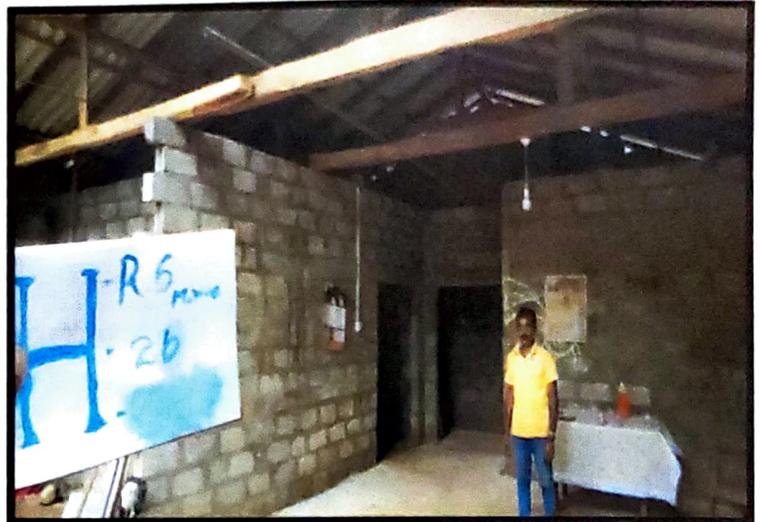
**Location** : RS Mine-Maduragoda  
**House No** : H 26  
**Name** : P Pushpalal  
**Address** : Kotuhena,Udaththapala  
 Maduragoda  
**GPS Coordinate:**  
 E – 174630  
 N – 264925

<b>(1) Identification number of house:</b>	H 26	
<b>(2) Photo notation:</b>	H <sup>RS Mine</sup> 26	
<b>(3) Approximate age of the house:</b>	02 years.	
<b>(4) Details of the land in which house was built on:</b>	Existing ground	
<b>(5) Existing structural detail</b>		
<b>5.1 Detail of the roof:</b>	Asbestos sheets	
<b>5.2 Detail of the walls:</b>	<b>5.2.1 Material type:</b>	Cement block
	<b>5.2.2 Thickness :</b>	-
<b>5.3 Detail of the plaster:</b>	No	
<b>5.4 Detail of the windows:</b>	Window frame only	
<b>5.5 Details of floor</b>	Concreted	
<b>5.6 Details of foundation</b>	Rubble & Masonry

<b>(6) Details of cracks at the Pre-Survey</b>			
<b>Pre-Survey</b>			<b>Remarks</b>
<b>Crack No</b>	<b>Length (cm)</b>	<b>Thickness (mm)</b>	
Note	-	-	No cracked & damaged at inspection time

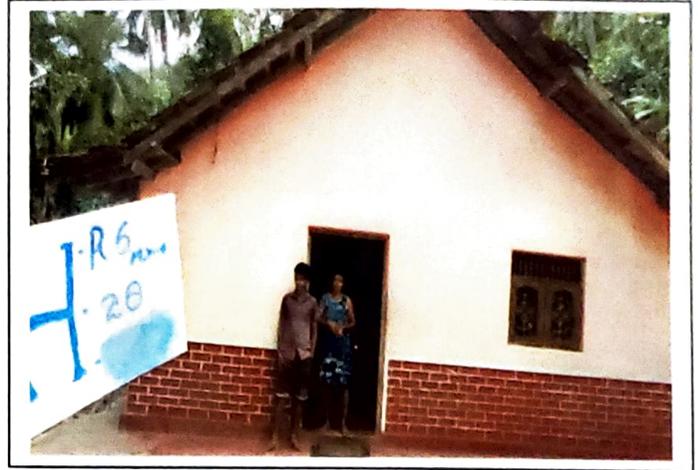
<b>(1) Identification number of house:</b>	H 28	
<b>(2) Photo notation:</b>	H <sup>RS Mine</sup> -28-23	
<b>(3) Approximate age of the house:</b>	25years	
<b>(4) Details of the land in which house was built on:</b>	Existing ground	
<b>(5) Existing structural detail</b>		
<b>5.1 Detail of the roof:</b>	Roof tiles standard	
<b>5.2 Detail of the walls:</b>	<b>5.2.1 Material type:</b>	Bricks
	<b>5.2.2 Thickness:</b>	-
<b>5.3 Detail of the plaster:</b>	Both side	
<b>5.4 Detail of the windows:</b>	Wooden & Glass	
<b>5.5 Details of floor</b>	Cement	
<b>5.6 Details of foundation</b>	Rubble & Masonry

<b>(6) Details of cracks at the Pre-Survey</b>			
<b>Pre-Survey</b>			<b>Remarks</b>
<b>Crack No</b>	<b>Length (cm)</b>	<b>Thickness (mm)</b>	
MC 01	23	Minor	Upward from left side of the window frame
MC 02	143	Minor	Downward from top to bottom on the wall
MC 03	25	Minor	Downward from on the wall
MC 04	60	Minor	Downward from on the wall
MC 05	59	Minor	Downward from on the wall
MC 06	28	Minor	Downward from right side of the window frame
MC 07	28	Minor	Downward from middle of the window frame
MC 08	45	Minor	Downward from on the wall
MC 09	61	Minor	Downward from on the wall
C 01	142	01	Downward from top to bottom along the wall joint –both side
C 02	109	01	Downward from top to bottom along the wall joint
C 03-I	142	01	Downward from top to bottom along the wall joint
C 03-II	43	01	Horizontally on the wall
C 04	55	01	Upward from left side of the window frame
C 05	47	01	Upward from right side of the window frame

<b>(6) Details of cracks at the Pre-Survey</b>			
<b>Pre-Survey</b>			<b>Remarks</b>
<b>Crack No</b>	<b>Length (cm)</b>	<b>Thickness (mm)</b>	
C 06	201	01	Downward from top to bottom on the wall
C 07	320	01	Downward from top to bottom on the wall-bothside
C 08	218	01	Downward from top to bottom on the along the wall joint
C 09	204	01	Downward from top to bottom on the along the wall joint
C 10	206	01	Downward from top to bottom on the wall-both side
C 11	84	01	Downward from left side of the window frame-both side
C 12	84	01	Downward from right side of the window frame-both side
C 13	225	01	Downward from top to bottom on the along the wall joint
C 14	56	01	Upward from left side of the door frame –both side
C 15	67	01	Upward from right side of the door frame-both side
C 16	52	01	Upward from left side of the door frame –both side
C 17	41	01	Upward from right side of the window frame
P	490*80		Pavement has been cracked

F	165*510		Floor has been cracked
F 01	500*130		Floor has been cracked

<b>(6) Details of cracks at the Pre-Survey</b>			
<b>Pre-Survey</b>			<b>Remarks</b>
<b>Crack No</b>	<b>Length (cm)</b>	<b>Thickness (mm)</b>	
A	60*110		Wall has been cracked
B	-		Pavement has been damaged
D	-		Roof tiles have been cracked

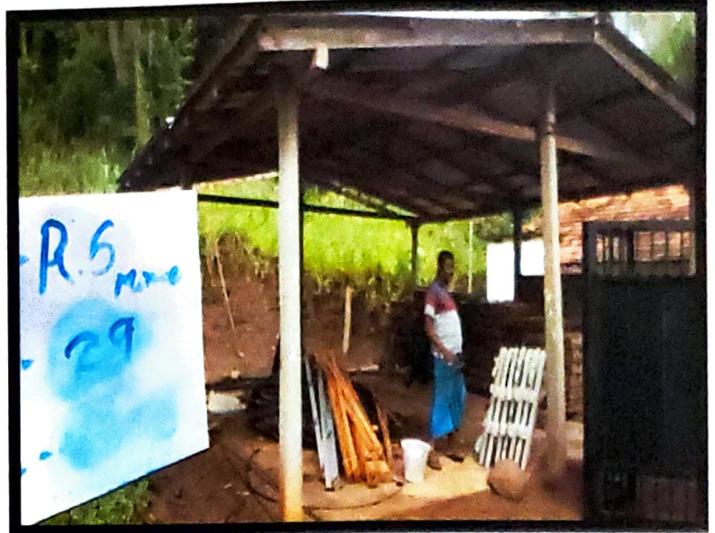
**Location** : RS Mine-Maduragoda  
**House No** : H 29  
**Name** : Shed,Queens Mine.  
**Address** : Kotuhena,Udaththapala  
 Maduragoda  
**GPS Coordinate:**  
 E – 174606  
 N – 264970

<b>(1) Identification number of house:</b>	H 29	
<b>(2) Photo notation:</b>	H <sup>RS Mine</sup> 29	
<b>(3) Approximate age of the house:</b>	04 years.	
<b>(4) Details of the land in which house was built on:</b>	Existing ground	
<b>(5) Existing structural detail</b>		
<b>5.1 Detail of the roof:</b>	Corrugated sheet	
<b>5.2 Detail of the walls:</b>	<b>5.2.1 Material type:</b>	-
	<b>5.2.2 Thickness :</b>	-
<b>5.3 Detail of the plaster:</b>	-	
<b>5.4 Detail of the windows:</b>	-	
<b>5.5 Details of floor</b>	Concreted	
<b>5.6 Details of foundation</b>	Rubble & Masonry

<b>(6) Details of cracks at the Pre-Survey</b>			
<b>Pre-Survey</b>			<b>Remarks</b>
<b>Crack No</b>	<b>Length (cm)</b>	<b>Thickness (mm)</b>	
Note	-	-	No cracked & damaged at inspection time

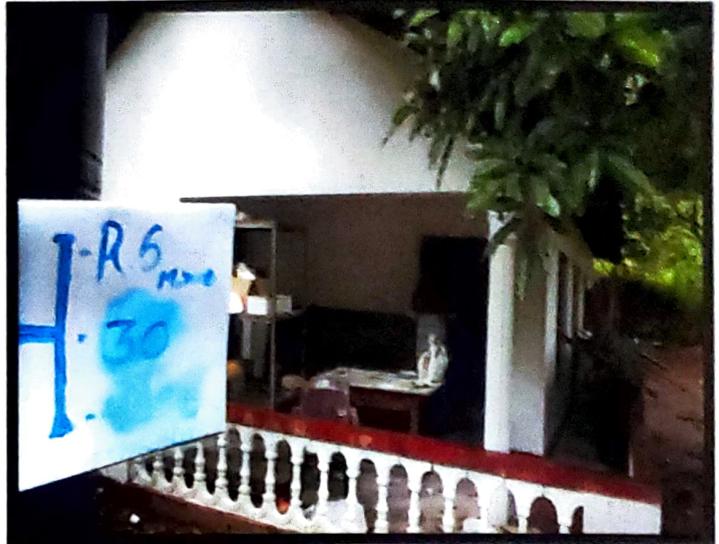
**Location** : RS Mine-Maduragoda  
**House No** : H 30  
**Name** : Queens Mine House.  
**Address** : Kotuhena,Udaththapala  
 Maduragoda  
**GPS Coordinate:**  
 E – 174617  
 N – 264985

<b>(1) Identification number of house:</b>	H 30	
<b>(2) Photo notation:</b>	H <sup>RS Mine</sup> 30	
<b>(3) Approximate age of the house:</b>	20 years.	
<b>(4) Details of the land in which house was built on:</b>	Existing ground	
<b>(5) Existing structural detail</b>		
<b>5.1 Detail of the roof:</b>	Asbestos sheet	
<b>5.2 Detail of the walls:</b>	<b>5.2.1 Material type:</b>	Bricks
	<b>5.2.2 Thickness :</b>	130mm
<b>5.3 Detail of the plaster:</b>	Both side	
<b>5.4 Detail of the windows:</b>	Wooden & Glazed	
<b>5.5 Details of floor</b>	Tiled	
<b>5.6 Details of foundation</b>	Rubble & Masonry

<b>(6) Details of cracks at the Pre-Survey</b>			
<b>Pre-Survey</b>			<b>Remarks</b>
<b>Crack No</b>	<b>Length (cm)</b>	<b>Thickness (mm)</b>	
Note	-	-	No cracked & damaged at inspection time

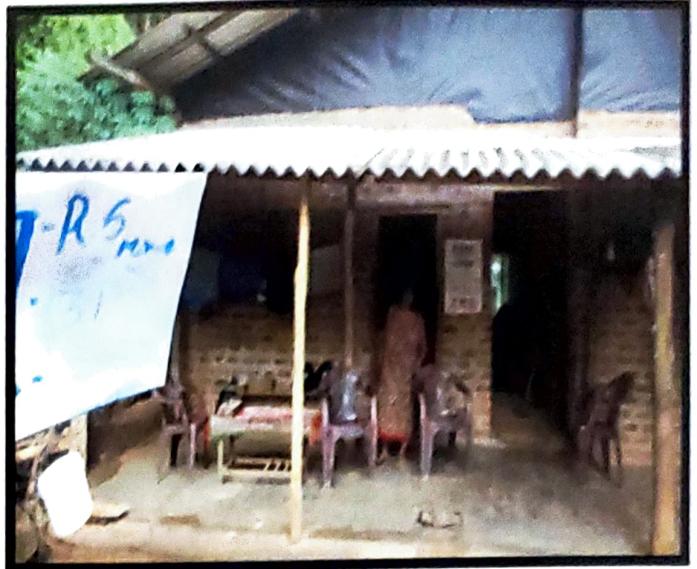
(1) Identification number of house:	H 31	
(2) Photo notation:	H <sup>RS Mine</sup>	
(3) Approximate age of the house:	5 years	
(4) Details of the land in which house was built on:	Existing ground	
(5) Existing structural detail		
5.1 Detail of the roof:	Asbestos Roofing sheet	
5.2 Detail of the walls:	5.2.1 Material type:	cement
	5.2.2 Thickness:	-
5.3 Detail of the plaster:	no	
5.4 Detail of the windows:	Window frame only	
5.5 Details of floor	Cement & Concreted	
5.6 Details of foundation	Floating foundation

<b>(6) Details of cracks at the Pre-Survey</b>			
<b>Pre-Survey</b>			<b>Remarks</b>
<b>Crack No</b>	<b>Length (cm)</b>	<b>Thickness (mm)</b>	
Note	-	-	No cracks & damages

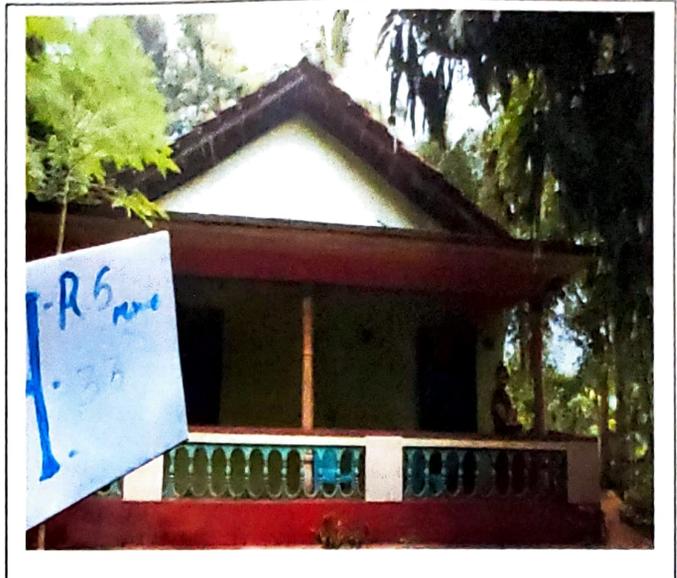
**Location** :RS Mine-Maduragoda  
**House No** : H 33  
**Name** :M.A.Pradeep  
**Address** :Udaththapala,Maduragoda  
**GPS Coordinate:**  
**E** – 174682  
**N** – 265100

<b>(1) Identification number of house:</b>		H 33
<b>(2) Photo notation:</b>		H <sup>RS Mine</sup> -14
<b>(3) Approximate age of the house:</b>		35years
<b>(4) Details of the land in which house was built on:</b>		Existing ground
<b>(5) Existing structural detail</b>		
<b>5.1 Detail of the roof:</b>	Roof tiles standard& Slab	
<b>5.2 Detail of the walls:</b>	<b>5.2.1 Material type:</b>	Bricks& cement blocks
	<b>5.2.2 Thickness:</b>	-
<b>5.3 Detail of the plaster:</b>	Some part	
<b>5.4 Detail of the windows:</b>	Wooden & Glass	
<b>5.5 Details of floor</b>	Cement & Concreted	
<b>5.6 Details of foundation</b>	Rubble & Masonry

<b>(6) Details of cracks at the Pre-Survey</b>			
<b>Pre-Survey</b>			<b>Remarks</b>
<b>Crack No</b>	<b>Length (cm)</b>	<b>Thickness (mm)</b>	
MC 01	97	Minor	Downward from along the wall joint
C 01	76	01	Downward from top to bottom on the wall
C 02	153	02	Upward from above the middle of the door frame-both side
C 03	183	03	Downward from top to bottom on the wall-both side
C 04	168	02	Downward from top to bottom on the wall-both side
C 05	137	02	Downward from top to bottom on the wall-both side
C 06	352	10	Downward from top to bottom on the wall-both side
C 07	251	08	Downward from top to bottom on the wall-both side
C 08	121	03	Upward from left side of the door frame
C 09	143	02	Upward from right side of the door frame
C 10	33	01	Upward from above the middle of the door frame
C 11	122	10	Downward from top to bottom on the wall
P	500*500		Pavement has been cracked
F	500*30		Floor has been cracked
A	300*180		Crack on the wall

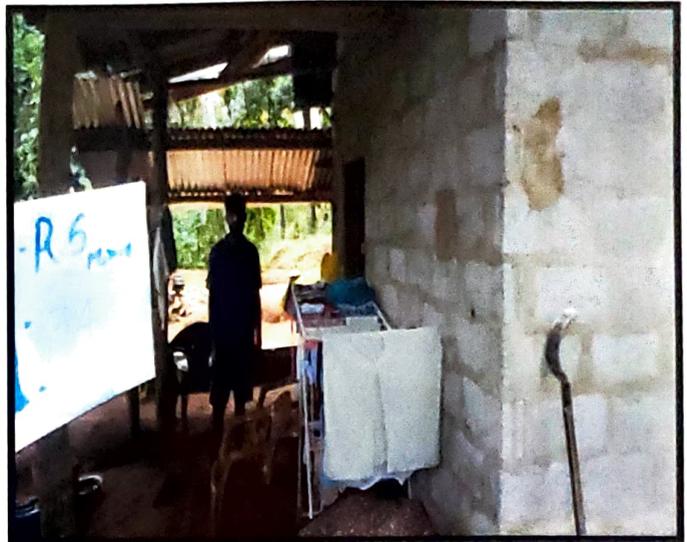
**Location** : RS Mine-Maduragoda  
**House No** : H 34  
**Name** : A Dhanapala  
**Address** : Kotuhena,Udaththapala  
 Maduragoda  
**GPS Coordinate:**  
 E – 174651  
 N – 265093

<b>(1) Identification number of house:</b>	H 34	
<b>(2) Photo notation:</b>	H <sup>RS Mine</sup> 34	
<b>(3) Approximate age of the house:</b>	02 years.	
<b>(4) Details of the land in which house was built on:</b>	Existing ground	
<b>(5) Existing structural detail</b>		
<b>5.1 Detail of the roof:</b>	Corrugated sheets	
<b>5.2 Detail of the walls:</b>	<b>5.2.1 Material type:</b>	Cement block
	<b>5.2.2 Thickness :</b>	130mm
<b>5.3 Detail of the plaster:</b>	No	
<b>5.4 Detail of the windows:</b>	Wooden & Glass	
<b>5.5 Details of floor</b>	Concreted	
<b>5.6 Details of foundation</b>	Rubble & Masonry
